**Journal of
Geography, Environment
& Planning**

Vol 8. No. 1., March, 2012.

DAMPNESS IN RESIDENTIAL BUILDING IN NIGERIA: A CRITICAL ASSESSMENT OF SUB – URBAN AREAS.

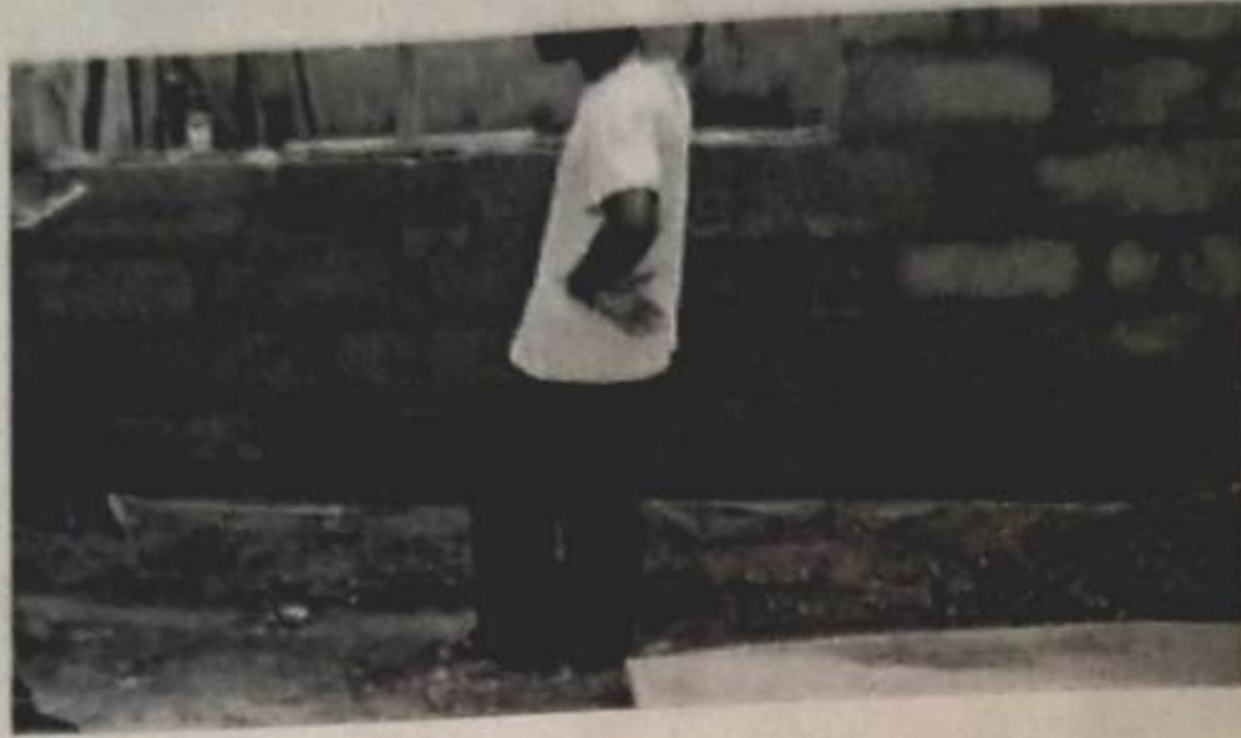
A thorough investigation and analysis of method and techniques of construction adopted in the area reveals that in most cases fewer people adopted the standard damp proof course (DPC) and damp proof membrane (DPM); instead cement/sand mix in ratio 1:6 is used for floors. It was also found that the hardcore thickness of 150mm adopted in most of the buildings as against the required 300mm is inadequate (especially where ground water levels were close to the ground surface). In areas where the ground water level is deep down and of stepper terrain, dampness is not visibly seen in buildings at such locations, whereas where the water level is high up, dampness is prevalent in most buildings found in the locality.

Figure 2. Building under construction showing DPM and Oversight Concrete

parts of the study areas, the application of damp proof membrane and the inclusion of damp – proof course to check the permeation of water through capillary action in the Foundation level and the walls should be carefully observed.

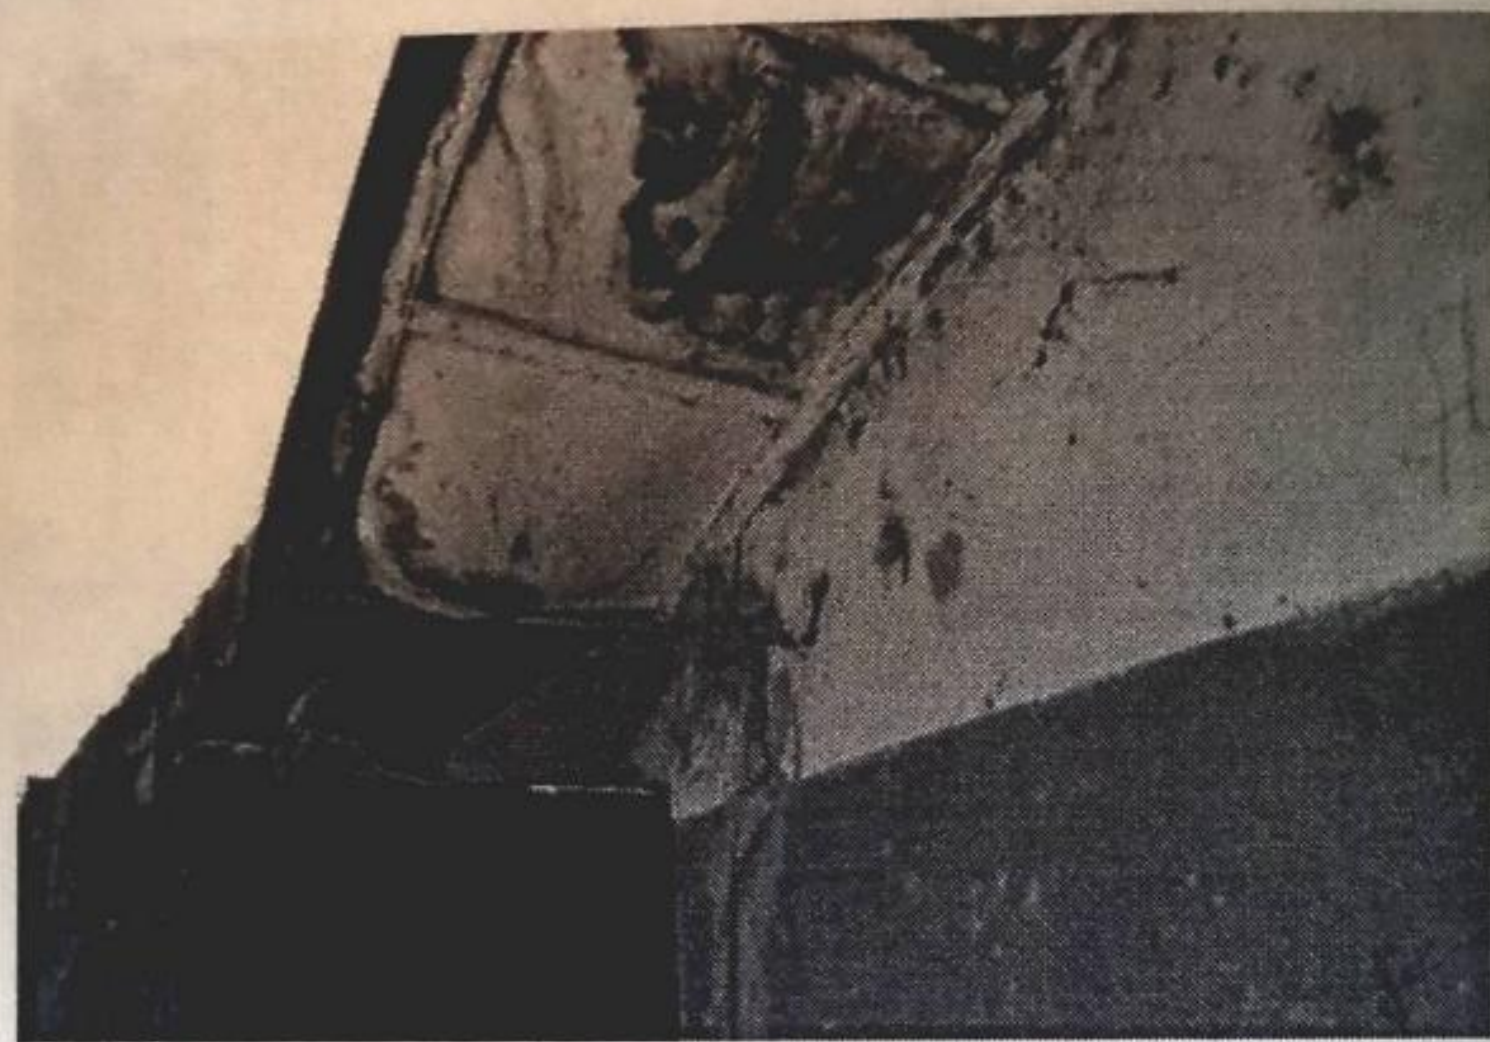
Figure 3. Damped facial board, ceiling and joist member.

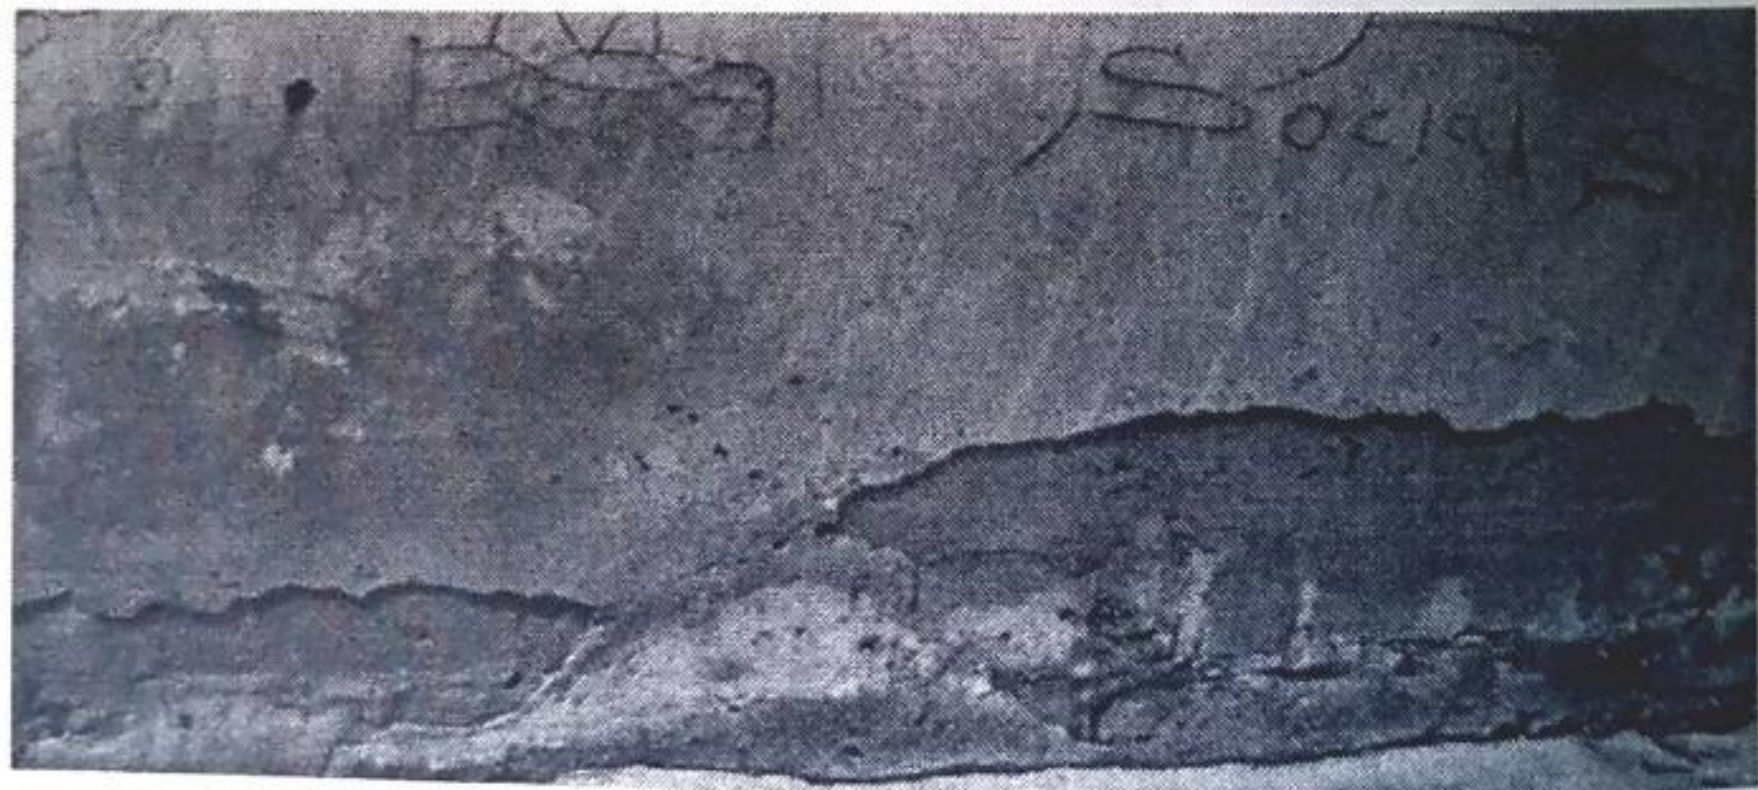
An average of 1 meter top soil was reported followed by 4-9 meters weathered basement that is hard enough at the basement to hinder free percolation of water that results to early saturation and flooding during raining season. This might be the cause of the high level of dampness (78%) in the foundation of buildings in area under consideration.

Figure 4. Severely Damped foundation and block walls.
