Engineering Failure Analysis

Road pavement collapse from overloaded trucks due to traffic diversion: A case study of Minna-Kateregi-Bida Road, Nigeria

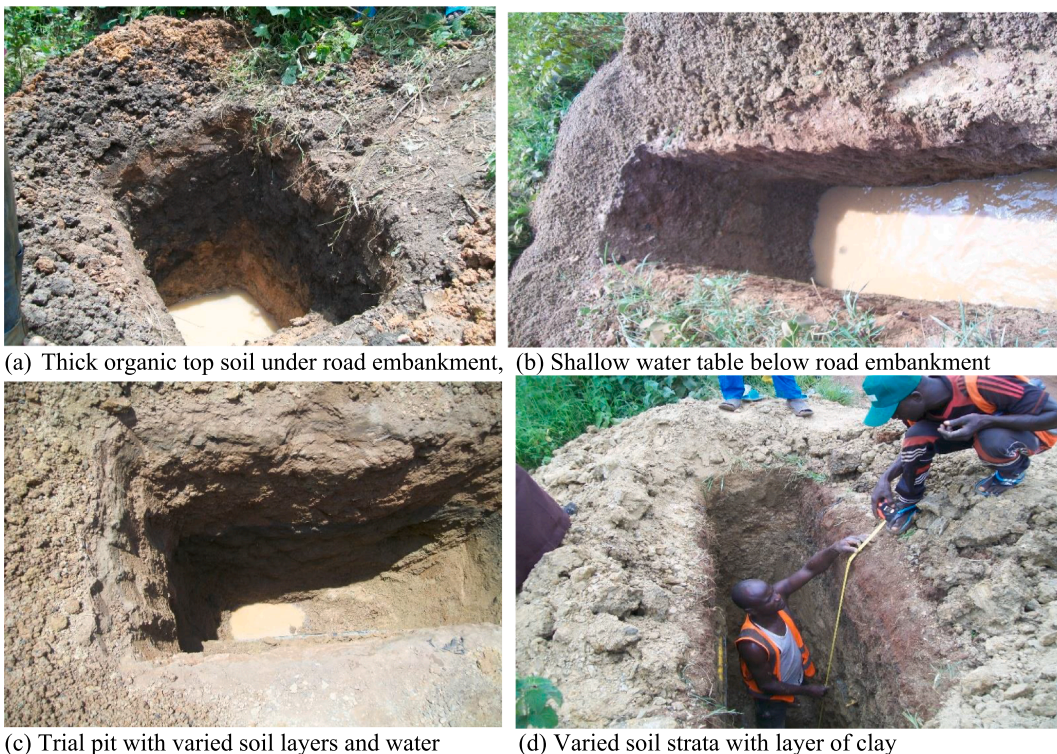
Fig. 3. Trial pit with (a) thick organic top soil (b), shallow water table, (c) varied soil layer (d) Bida basin.

Fig. 3a is a typical example of thick organic top soil underlying the road embankment while Fig. 3b indicate occurrence of shallow water table in some sections of the road. Fig. 3c and 3d are similar with the former having a thin layer of dark organic soil between brownish lateritic soil from the top while the later have highly plastic clay layer between a reddish brown soil from the top (see Fig. 4).

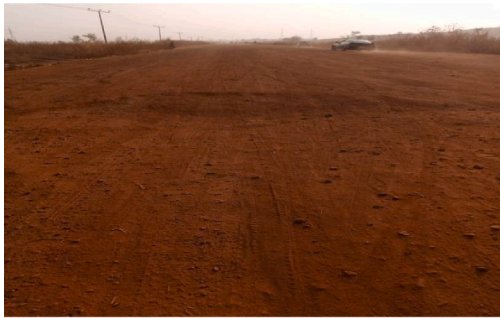
(a) Stripped asphalt surface with depression

Fig. 4. Pavement surface with (a) stripped asphalt surface, (b) wide potholes, (c) depressions, (d) cracks.

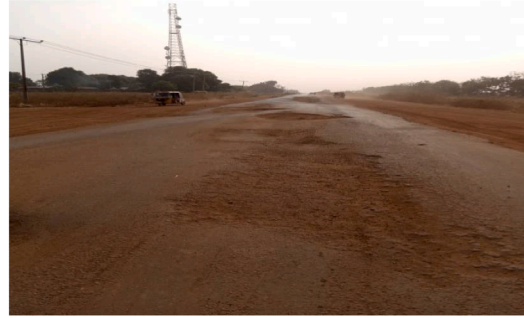
(b) Rough surface with wide potholes

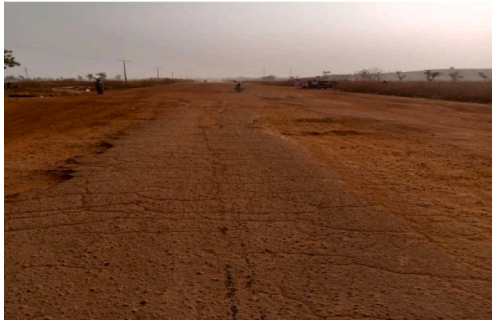
(c) Pavement surface with depressions

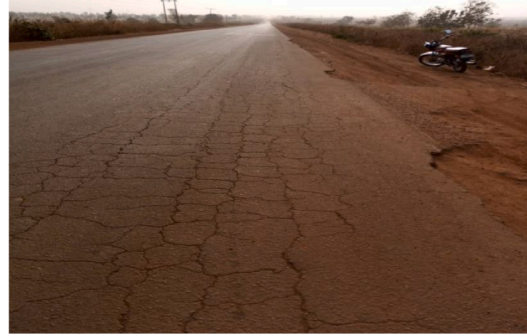
(d) Pavement with alligator cracks

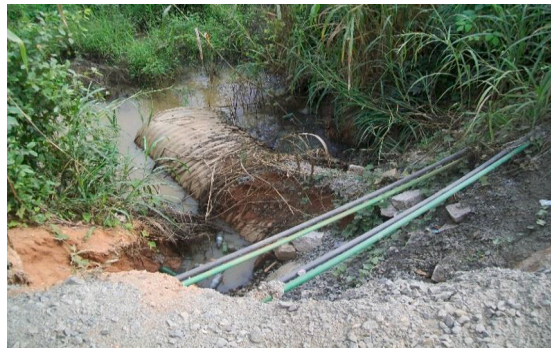
A section from CH 56 + 000 to CH 59 + 000 consists of a wide basin which was filled with high embankment and the running water channeled across the road through two bridges and many thin metal tubes. While the two bridges were observed to be grossly inadequate to channel the water across the road, the thin metal sheets tubes, intended to also channeled flood water across the embankment were observed to be rotten and failed under the embankment load, thus reducing the rate of water flow through the embankment as shown in Fig. 5. These Setbacks have allowed ingress of water in to the embankment, thereby causing the collapse of pavement over this embankment within some sections as shown in Fig. 6.

Fig. 5. Hollow metal sheet as water channel.

The section with failed sheet pipes transporting water across high embankment can be rectified by removing the failed sheet pile, replaced with more stable material and recompacted to predetermined density.

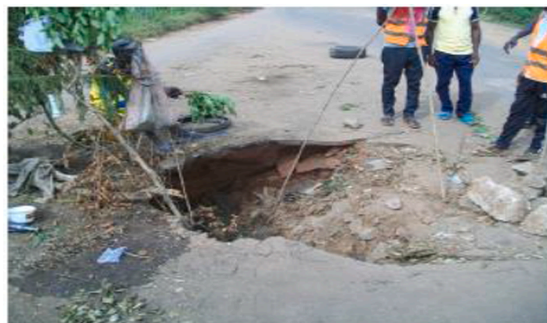
Fig. 6. Pavement failure over the embankment.

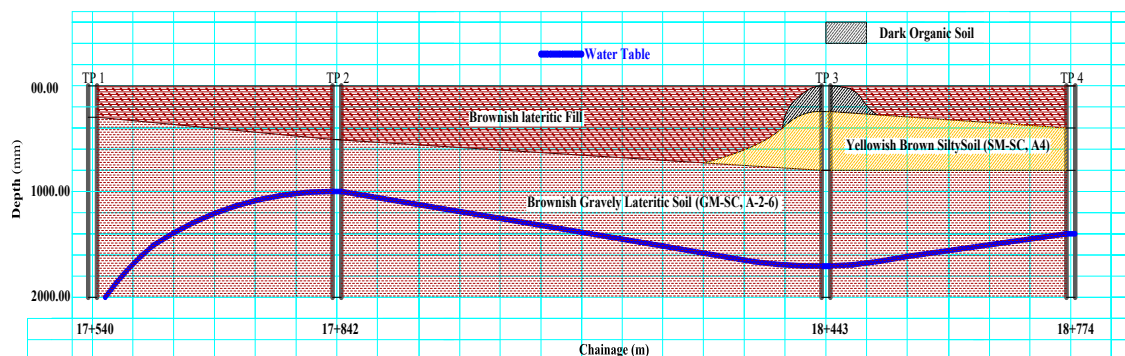
The profile consists of 0.3 m – 0.8 m thick brownish lateritic fill material brought in during the road construction. This layer was intruded by yellowish brown silty soil from trial pit 3 to trial pit 4, which classified as A-4 based on American Association of State Highway and Transportation Officers (AASHTO) soil classification system. Some researchers ([25,26,23,24]) have reported the effect of road subsoil materials on the strength and stability of the road structures. However, this type of soil can serve as natural subgrade material for road structures with optimal stability. A little lens of organic soil was observed very close around TP3. Water table was observed to be generally shallow at depth of between 0.6 m and 1.0 m below the lateritic fill material. The influence of water table on the performance of pavement sub-structures have been identified by Bassam [27] and Toll et al [28]. The authors have revealed that high water table affects the strength of pavement sublayers grossly. According to Adlinge and Gupta [32], the shallow underground water table can seep in to the upper road structure through capillary rise which must have weakened the sublayers of the road structure thereby resulting to sudden failure with heavier traffics.

Fig. 7. Profile within collapse section from CH 16 + 672 and 19 + 000.

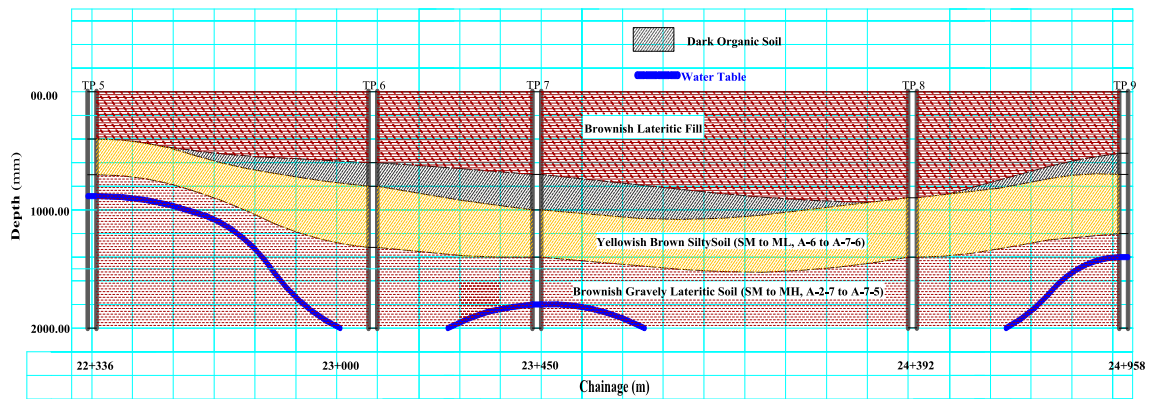
This stretch of the road is also located within the basement complex section of the road. Five trial pits (TP5 – TP9) were conducted within this section as shown in Fig. 8. The profile shows brownish lateritic embankment brought in during the road construction as the upper layer, followed by relatively thin layer of organic matter content. The presence of this layer of organic matter is an indication that the organic top soil was not removed before placement of lateritic fill embankment. This layer is underlain by a relatively thick yellowish brown silty clay soil layer spanning through the entire stretch of the profile. The layer classified as A-6 to A-7-6 based on AASHTO soil classification system which is susceptible to swelling and shrinkage. Below this layer is a stable brownish gravelly lateritic soil. Shallow water table was observed in some sections along the chainages as shown in the profile. The total collapse of the pavement observed in this stretch of the road must have resulted from combined action of organic soil underlying the embankment, highly plastic clay underlying the organic soil and the action of shallow water table observed in some sections along the stretch of the road. Adlinge and Gupta [32] have also shown that poor subgrade like organic soil and heavy clay can be overstressed by heavy traffics, thereby leading the sudden failure of pavement structures (see Figs. 9 and 10).

Fig. 8. Profile within collapse section from CH 22 + 320 and 25 + 100.

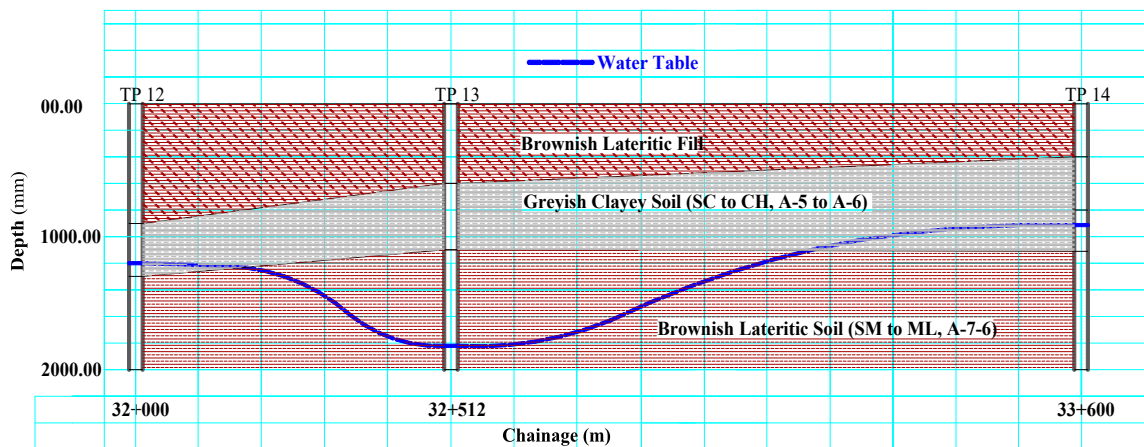
This section of the road also exists within the basement complex section. It consists of three trial pits (TP12 to TP14) taken to depth of 2.0 m each. The profile is covered from the top by a brownish lateritic fill which is underlain immediately by a relatively thick clay of high plasticity (CH) based on unified soil classification system. The layer is then underlain by stable brownish lateritic soil down to depth of 2.0 m. Water table was also recorded at shallow depth of between 1.2 m and 1.8 m. The collapse of this stretch of the road is clearly due to depression of the clay stratum due to axle load from heavy trucks plying this road. The shallow water table has always kept the clay under perpetual softness due to continuous presence of moisture through capillary rise.

Fig. 9. Profile within collapse section from CH 32 + 000 and 33 + 781.

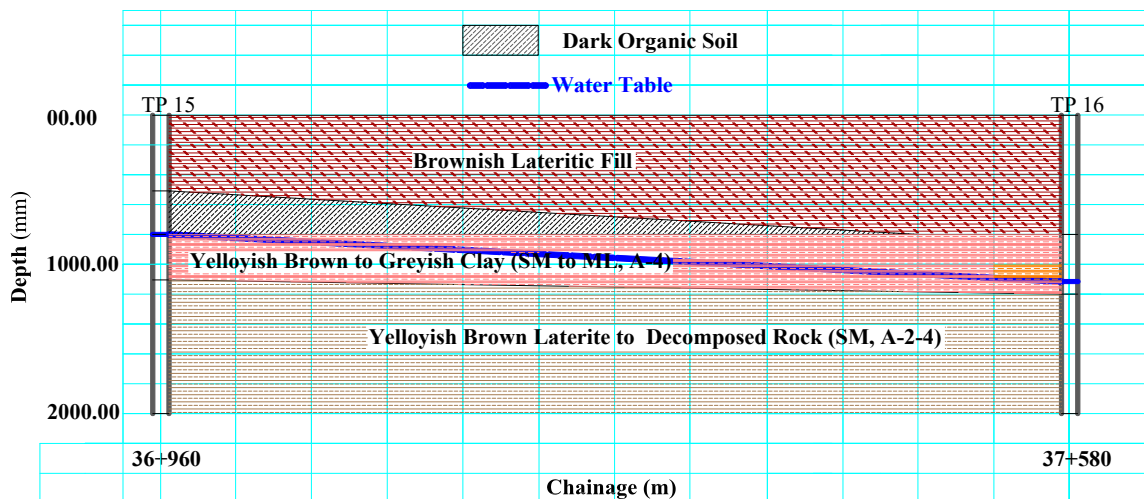
Fig. 10. Profile within collapse section from CH 36 + 790 and 37 + 780.

observed below the organic soil layer. Stiff lateritic soil layer was recorded below the greyish clayey soil. Water table was observed at shallow depth of between 0.8 m and 1.2 m. It can therefore be inferred that the collapse of this section is attributable to shallow water table and the organic material underlying the road embankment.

The possible remedial measures will depend on the nature and causes of the failure. The sections with stable subgrade but consists of shallow water table can be repaired by increasing the embankment height so as to take the pavement structure far from the water table.

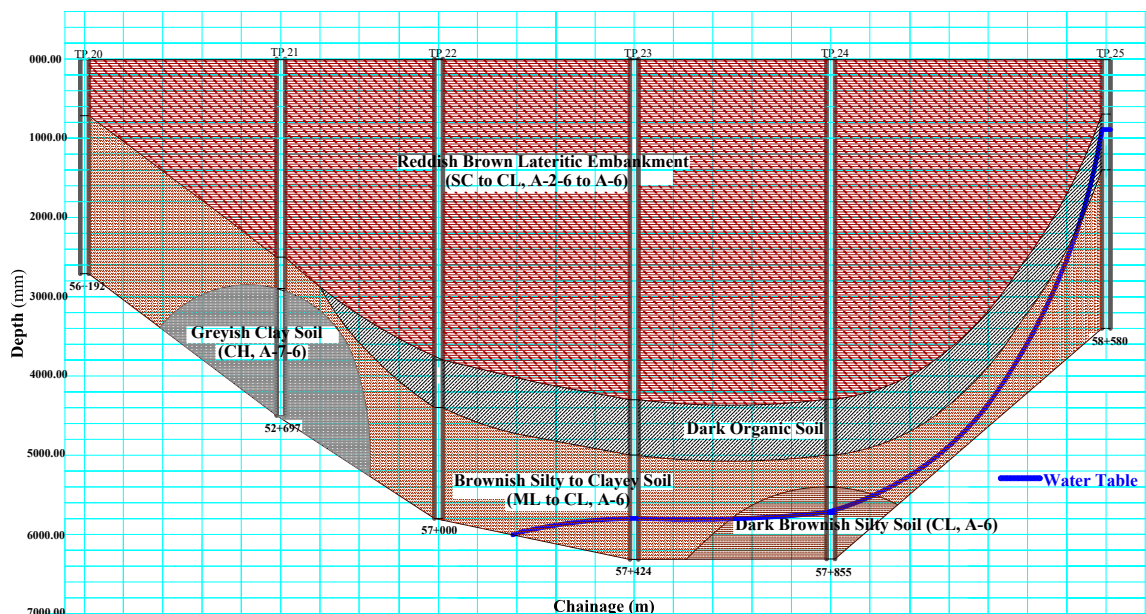
This section of the road, which stretched for about 4.0 km, falls under Bida basin and comprises of trial pit 20 to 25. The channel consists of a body of water dammed by the embankment and tends to flow across the road through two bridges and some sheet tubes. These sheets were observed to have failed under the embankment disallowing free flow of water across the embankment. This must have informed the water table observed in trial Pits 22 to 25 in Fig. 11. The profile showed thick, reddish brown lateritic embankment ranging from 0.8 m thickness to 4.5 m thickness. This embankment was brought in during construction without the removal of the dark organic soil immediately below the embankment. A localized greyish clayey soil was observed in TP21 which intruded the underlying brownish silty soil synonymous to basin soils. Failure of this embankment as shown in Figs. 5 and 6 must have resulted from a combined effect of the organic soil below the embankment and the failure of the sheet tubes used to channel water across the embankment. The mode of failure of embankment under this condition can be likened to the study by Bardet et al (2015) and Kuliczowska [33] who both explained the process as progressive erosion of bedding, cavity formation and subsequently, pavement collapse. Infiltration of ground water with soil particles in to the pipe is another great threat to pavement structure. This will cause the soil underneath to subside and consequently lead to the failure of the pavement (see Fig. 12).

Fig. 11. Profile of Trial pits at Critical Failed section between CH 55 + 520 to CH 59 + 100.

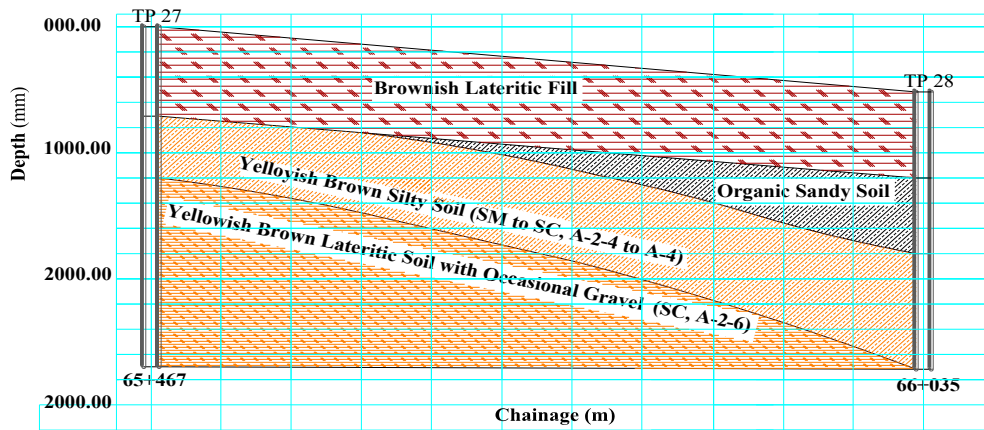
This failure section also falls under the Bida basin which contains TP27 to TP28. The profile is covered from the top by a brownish lateritic fill material which was also brought in during construction of the road. This layer of the soil is underlain by organic soil within the area of TP28 which in turn, is underlain by relatively thick yellowish brown silty soil which cut across the entire stretch of the section. The entire profile, without water table, was than underlain by lateritic soil with occasional gravels. The collapse of this section of the road can be attributed to the organic soil directly below the embankment and the loose nature of the silty soil prevalent on this site. The organic matter indicates poor subgrade which cannot resist the pressure from heavy traffics.

Fig. 12. Profile of Trial pits at Critical Failed section between CH 65 + 405 to CH 66 + 125.

Where the embankment is founded directly above weak organic soil as well as fat clay, this section of the road should be excavated to remove the poor subgrade materials and replaced with better materials.
