Buildings Collapse and Socio-Economic Development of People in the Federal Capital Territory, Abuja, Nigeria

This study examined buildings collapse and its effects on the socio-economic development of people in the Federal Capital Territory, Abuja. A collapsed building at house number 54 on Oba Overanwen Road in Gwarimpa Housing Estate was used as a case in point to ascertain the remote causes of its collapse. Factors, such as failure in foundation, the use of poor and substandard building materials, cement adulteration and seepage of ground water into foundations were investigated. The study adopted the expository and experimental approaches. Findings showed that the bearing capacity of the underlying soil in Gwarimpa collapsed site is 17.5% below the load intensity exerted on it. Concrete specimens obtained from the site and tested gave very poor results which did not meet minimum required strength of concrete of 1:2:4 or 1:3:6, respectively. Steel reinforcement bars tested also showed inadequate characteristic strength (f_y) well below 410N/mm². This study discovered among others that most of the high rise buildings do not have provision for collection and channeling of storm w

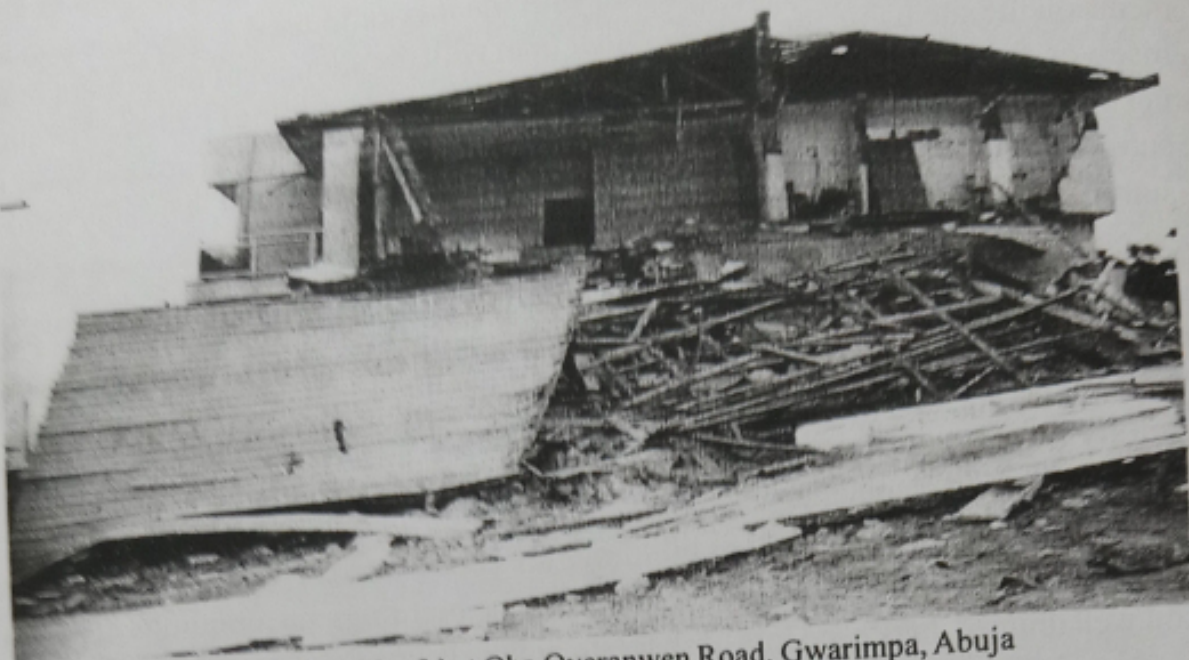
Six samples of concrete specimens were recovered from the site and tested using the non destructive test method (rebound hammer). As shown in Table 6, average strength of concrete obtained was $25.4/6 = 4.23\text{N/mm}^2$. This result is 78.85% poor compared to concrete grade 20. The average values of the characteristic strength and nominal reinforcement sizes were 394N/mm²/11.38mm, 321N/mm²/14.80mm and 335N/mm²/19.41mm for diameters 12, 16 and 20 bars. This result gives 5.17%, 7.5% and 2.95% less than the required sizes for 12, 16 and 20 diameter bars respectively. Results of the non destructive concrete tests of the recovered concrete specimens from the collapsed site were very poor and fell below the minimum required strength for concrete whether 1:2:3 or 1:3:6 grade 25 concrete type. It is also evident that poor concreting coupled with poor construction practices and inadequate foundation are some of the major reasons why the building on 54 Oba Overanwen road Gwarimpa collapsed (Matawal, 2012).

During investigation of foundation depth, it was found that the average depth was about 450mm and the concrete footing thickness was also found to range between 120mm and 200mm which is a far cry from the minimum depth of 750-900mm for bungalows and 300-450mm for footing thickness according to Barry (1976). It should be noted that the bearing capacity was calculated at the depth of 1.0 meter and foundations shallower than this depth are likely to stand on lower bearing capacities. Foundation checks show that most of the buildings stand on very shallow foundations with an average depth of 450mm and footing thickness ranged between 120 and 200mm. This study identified poor concreting and foundation failure as the major causes of the collapse. The study identifies the causes of building collapse during construction and post construction stage and presents the result in Table 9.

Figure 1: Collapsed House No. 54 at Oba Overanwen Road, Gwarimpa, Abuja

There is also the need for the depth of excavations to be inspected before concrete foundations are casted. This will greatly reduce the problem of shallow foundations as was discovered during findings. If the bearing capacity is calculated at 1.0 or 1.5 meter depth and the foundation depth at construction fails to reach depth mentioned, there is the likelihood that failure will occur. Besides the depth check, there is the need for concrete foundation thicknesses to be pre gauged by site supervisors before commencement of concrete casting. This will help eliminate in adequate thickness of foundations.

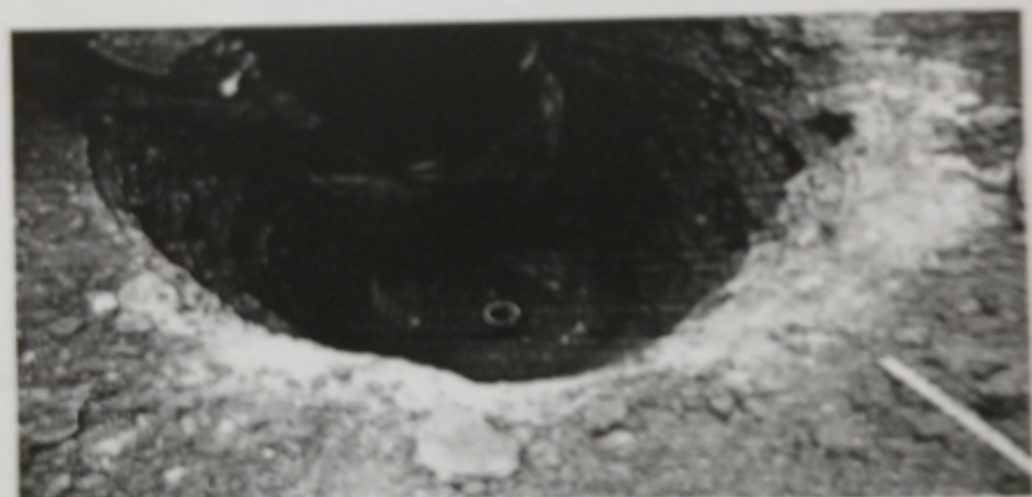
Figure 2: Trial pit with soil core cutter Source: Fieldwork, 2015

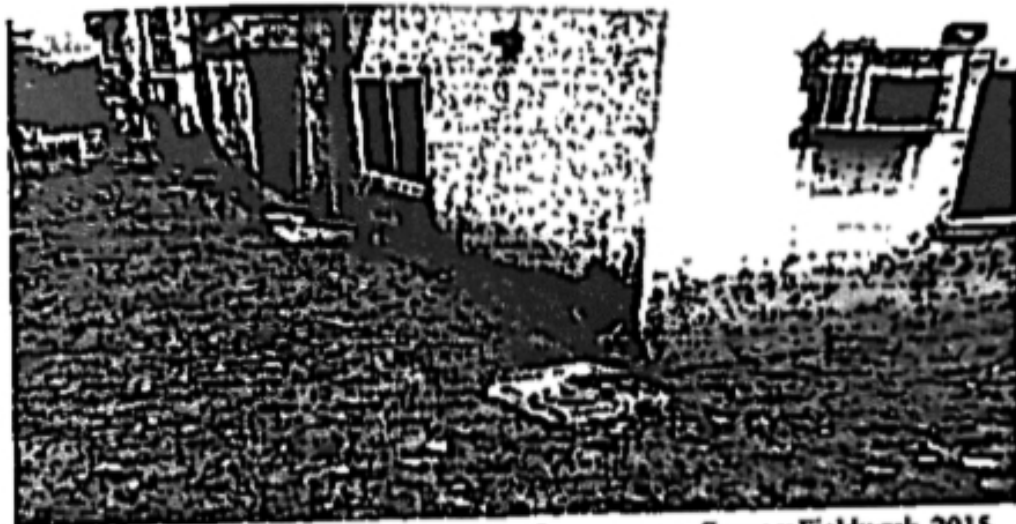
If drainages are provided as buildings are constructed, a lot of excess water will be transported away from the buildings, leaving the buildings surroundings dry and the subsoil well drained, hence, no loss of shear strength or bearing ability of the soil; and it will also reduce differential settlement. Investigation further revealed that virtually all the high rise buildings within Gwarimpa have no provision for collection/channeling of storm water away from the buildings. It has been established that nearly all collapses occurred during the rainy season (Ede 2010). The building structures stand on shallow foundations which carry heavy loads and sit on underlying soils which have low bearing capacities. The excess moisture in the subsoil causes dampness of the walls in the buildings which also leads to spalling of plaster and concrete. In this study, it is also discovered that most of the high rise buildings do not have provision for collection and channeling of storm water away from the buildings, thereby causing weakness to the underlying soil in foundations due to excess water intake during the rainy season.

Figure 5: No drainage provision in Gwarimpa

There is the need for the collection and channeling of storm water either through the construction of drainages/gutters around high rise buildings or the provision of septic tanks or any other method of channeling excess water away from the surroundings of the buildings in order to keep the foundations safe from being over saturated with water which leads to shear failure. Government must, through the standard organization, ensure availability of only good quality materials for the construction market. Cost reduction measures need to be employed to reduce the cost of construction. Dealers in poor quality construction materials should desist from such act. There is need for materials testing laboratories. This intervention will provide easy access to testing facilities so that there is no excuse for not supervising any project comprehensively. Government must demonstrate adequate interest in project safety by prosecuting, with all seriousness, offenders whose activities result in the collapse of structures.

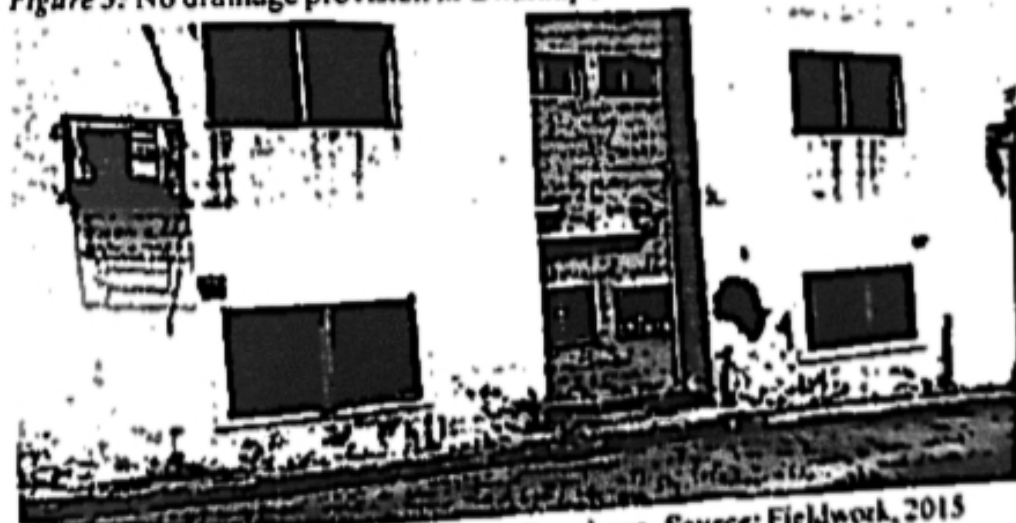
Figure 6: High rise building without drainage in Gwarimpa. Source: Fieldwork, 2015
