Influence of Geology and Groundwater Fluctuation on the Instability of Road Pavement between Shango and Paiko along Minna – Lambata Road, Central Nigeria

S.H. Waziri¹, C.O. Okogbue², N.M. Waziri^{1,2}, I.N. Abdullahi¹

¹Department of Geology, Federal University of Technology, Nigeria

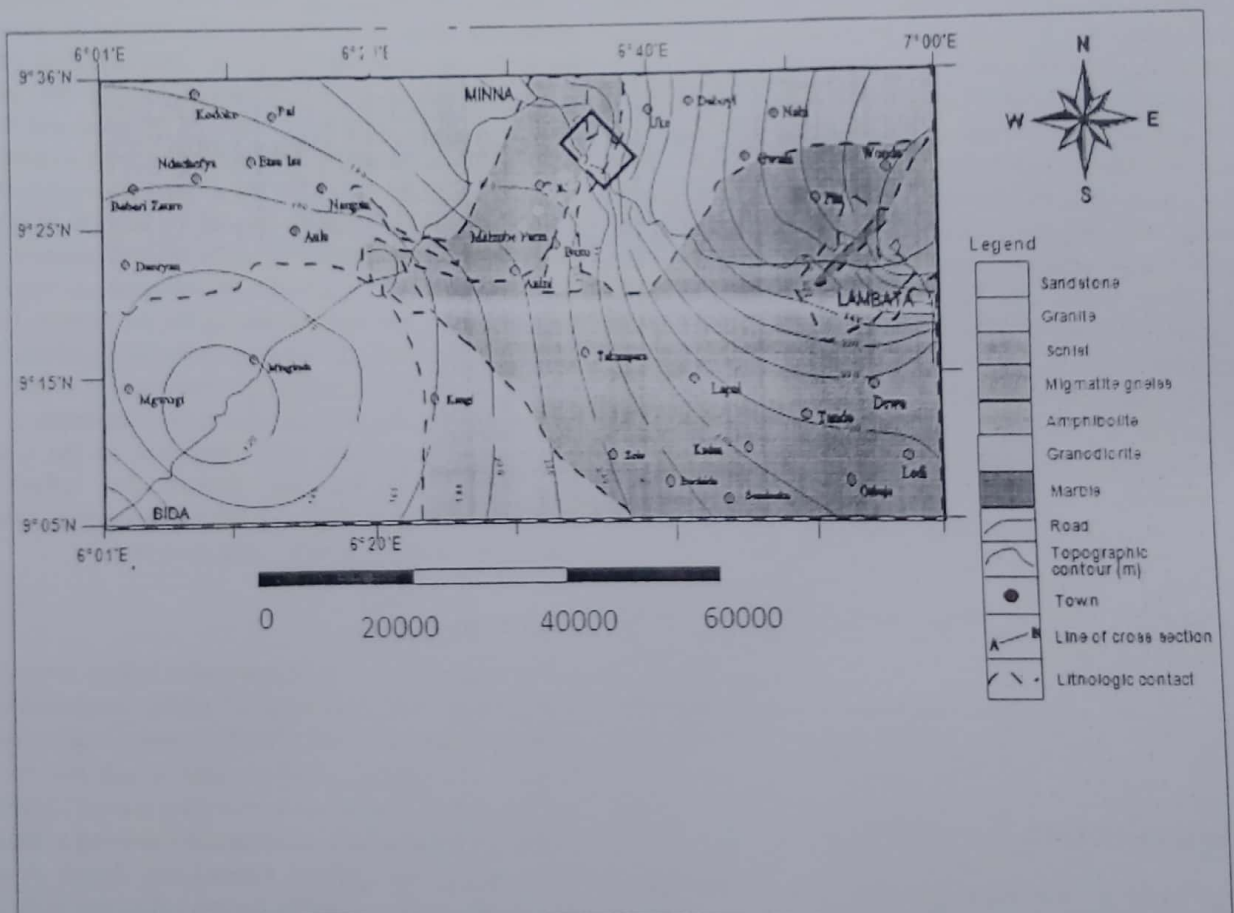
Figure 1. Geology of the study area. Study area is indicated as a rectangle in the top of the map.

Observations from figure 1 show that the problem area is underlain by schist, granodiorites poorly fractures granites. The schists are found at a lower elevation and have been shown to be highly fractured and jointed due to the intrusion of the older granites in the Minna area. This intense fracturing and jointing has allowed the percolation of rain water, thus, considerably weakening the rocks and has transformed the rocks to unstable foundation material. The resulting lowered bearing capacity of the rocks and the subgrade is thought to have influenced the performance of the road at this portion. The studied rocks are made up of calcium-rich feldspars and dark minerals which are high in the weathering order (i.e., unstable). All these constituents have weathered to form amorphous hydrous oxides and clay minerals. Some of the minerals identified in the metamorphic rocks in the study area include hornblende, biotite, chlorite and sericite. Because the mafic minerals (most weatherable) are concentrated in schists and amphibolites, they have become susceptible to weathering. This property has proved troublesome in engineering [11].
