QUALITY OF ROAD TRANSPORT INFRASTRUCTURE IN MINNA METROPOLIS, NIGERIA

Oluwole, M.S.^{1*}, Ojekunle, J.A.¹, Masugari, D.Y.², Usman, A.K.³, Dalil, M.⁴
and Abdullahi, M.I.¹

¹Department of Transport Management Technology, Federal University of Technology, Minna.

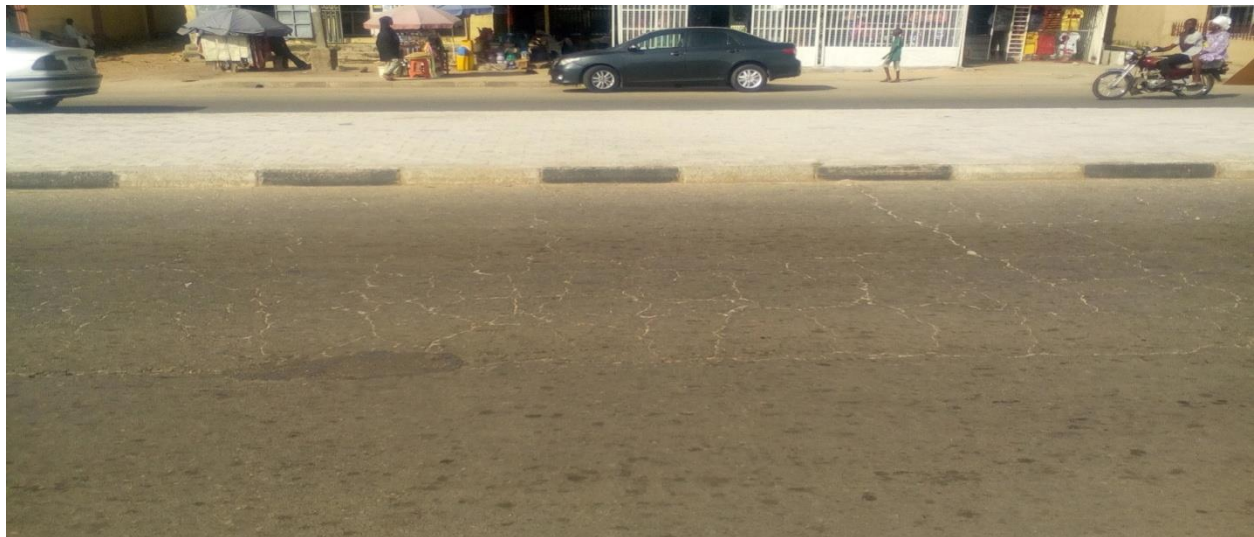
The total length of the arterial roads is about 80.66 km. The surface condition is observed to be good along Maitumbi Junction, fair along Eastern by-pass and Gwada junction and very poor along Bida road. The Bida road rated to be very poor has numerous large, deep potholes and alligator cracks. The basis of this classification is on the number and size of potholes and cracks noticed along the roads, Paiko road surfacing is poor because it has lots of small sized potholes and cracks, while Eastern bypass and Gwada road had few small-sized potholes and alligator cracks. The Maitumbi road is free from potholes and cracks as at the time of the study hence the good ratings. The length of each of arterial road as a proportion of the whole was computed in order to determine the percentage of the arterial road with good surfacing and the outcome is presented as Figure 2. Deriving from this, 72% of the arterial road network in Minna metropolis

has no good surfacing, while only 28% have good surfacing. Plate I shows some alligator cracks along Bosso Road- Minna.

Plate I Alligator cracks along Bosso Road

Alligator cracks on all roads should be sealed and all the potholes should be filled immediately in order to improve the road quality and reduce the spate of deterioration of the roads, reduce damages and maintenance costs to motorists. The damaged traffic lights should be repaired and provision of more traffic lights should be considered for all the arterial and collector roads. Furthermore, strict enforcement should be instituted by the Niger State Vehicle Inspection Office (VIO), while violators should be adequately sanctioned.

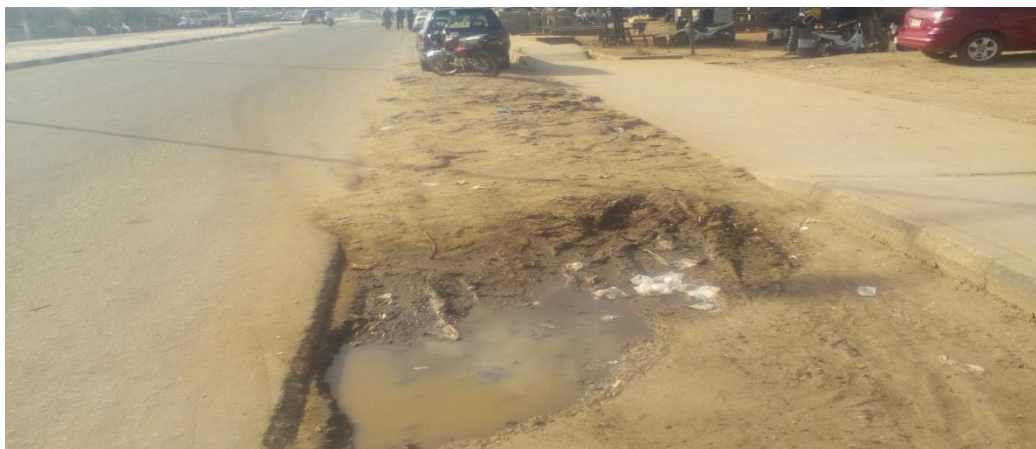
The generalized condition of road shoulder in the study area is presented in Table 5. It shows that 94.1% of the roads had road shoulders, while all other (5.9%) had no road shoulder. About 31% of the roads are in very good condition, meaning that they have surfacing without cracks or potholes. The edges are smooth and wider enough to accommodate any vehicle that wants to park from the main road. One-quarter is in good condition, i.e. the road shoulder surface has few cracks and/or small sized potholes, while 12.5% are in fair condition. The implication of this result is that about half of the road shoulders in Minna metropolis are in good condition. Plate II shows the condition of road shoulders along Bosso road, Minna.

Plate II: Condition of Road Shoulder on the Bosso Road

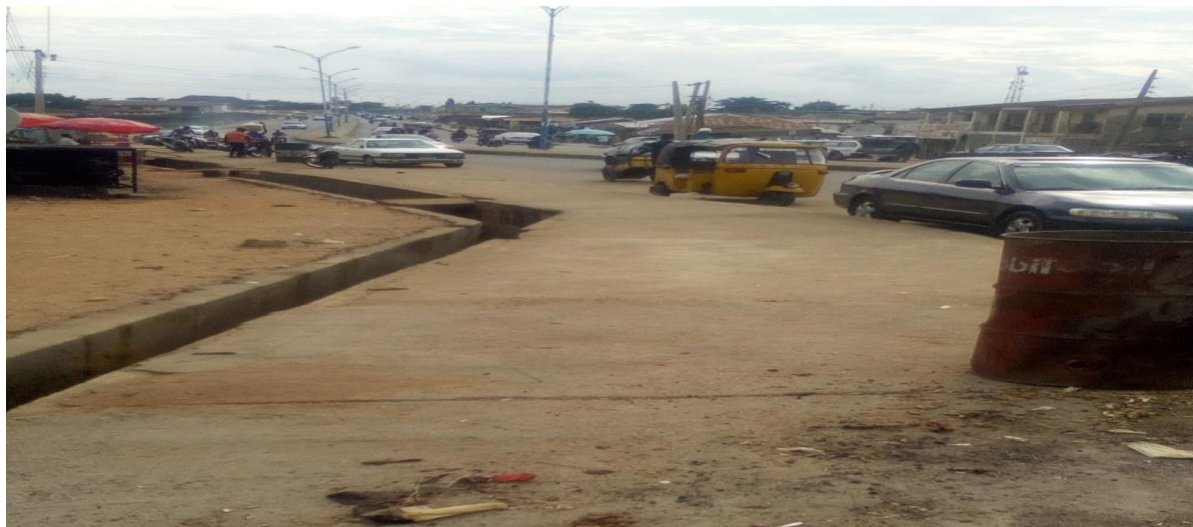
From Table 7, 70.6% of the roads have pedestrian walkways, while 29.4% do not have pedestrian walkways while 66.7% of the roads with pedestrian walkways are in good condition while 16.7% are in fair condition and 16.7% in bad condition. Plate III shows the condition of pedestrian walkways along Airport Road.

Plate III: Pedestrian Walkway along Old Airport Road

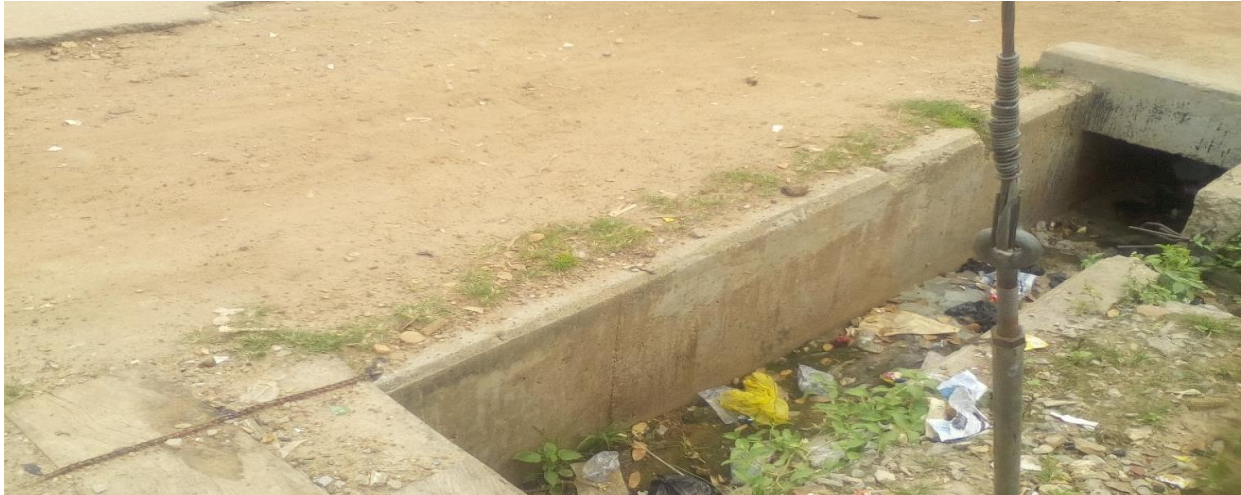
From Table 8, 64.3% of the drainages in the metropolis were in bad condition, with the drains filled with sands, refuses and rubbles (as shown in Plate IV) which do not allow the flow of water, while 17.6% of the roads have no drainage. 35.7% of the roads with drainages were in fair condition, these drainages though still allowing the flow of water, it also had some refuse and needed clearance to prevent it from getting blocked.

Plate IV Blocked Drainage along Stadium Road

Furthermore, pedestrian crossings in the metropolis should be repainted and pedestrians should be enlightened on the benefits of using the facilities while also stressing the dangers of neglecting them. Finally, the drainage systems should be well maintained through regular clearing of the channels and tunnels to avoid blockages.

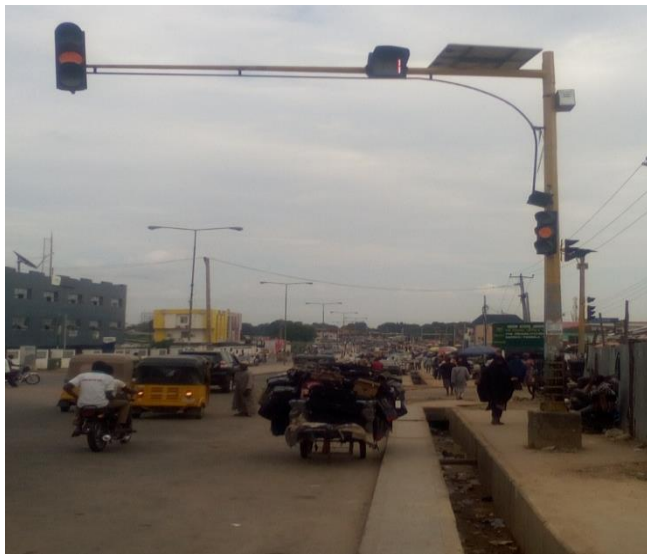
Information regarding the availability and condition of traffic lights on Minna roads is presented in Table 9. There are a total of twelve (12) traffic lights in the metropolis, ten (10) on the arterial roads, of which only six (6) are functional and two (2) on the collector roads and both were functioning. As attested to by the residents around the area during the survey, the damaged traffic light which shows red light all the time (Plate V) have remained in such condition for weeks.

Plate V Damaged Traffic Light along Bosso Road

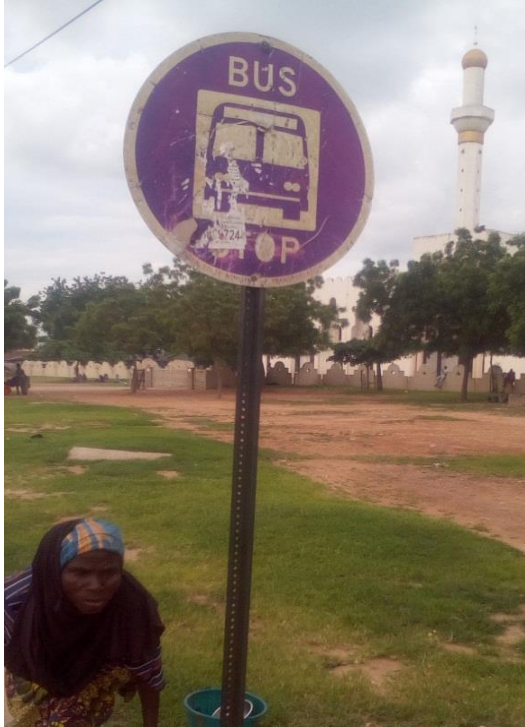
The major road signs noticed in the study area were the “Stop”, “bus stop” and the “bumps ahead”. Unfortunately, they are rarely obeyed by motorists Plates VII, VIII and IX shows typical road sign, pedestrian bridge and island in Minna metropolis.

Plate VII: A Bus Stop Sign along Bosso Road

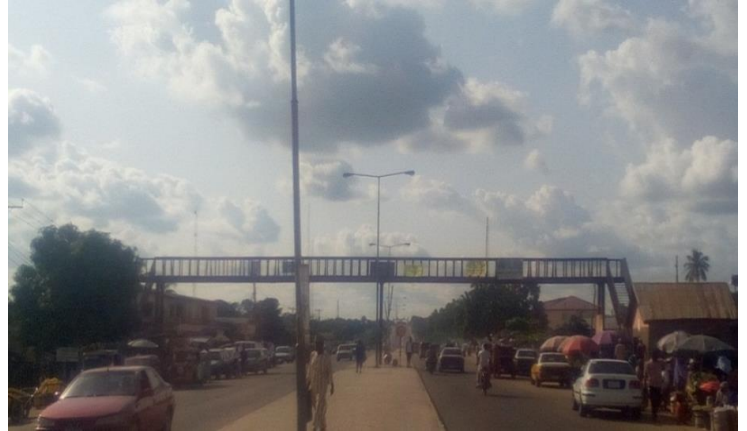
There are six (6) pedestrian overhead crossings along Bosso road and one on the Western Bye Pass. The pedestrian overhead bridges are rarely used and only serve as beautification for the streets, the Zebra Crossings are the common pedestrian crossing in the metropolis and there are about seven of them along the arterial roads although the marking have faded away and rarely used by pedestrians nor obeyed by motorists.

Plate VIII: A Pedestrian Overhead Bridge on the Bosso Road
