# The October 13, 2010 Landslides on the Azenge Mountain in Imande Ukusu, Nkomon District, Benue State, Nigeria

Ako Thomas Agbor\*, Abba Francis Mohammed, Onoduku usman Shehu, Nuhu Waziri Musa, Alabi Adekola A., Mamodu Adegbe

Department of Geology, School of Natural and Applied Sciences, Federal University of Technology, Minna, Nigeria

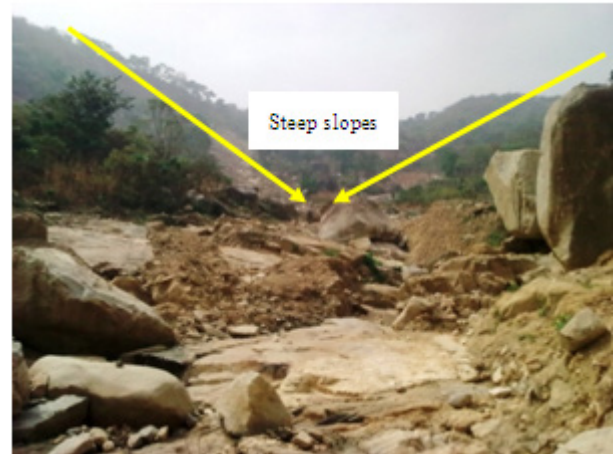
fractures in the rocks must have brought about gradual weathering (Figure 4). This resulted in slow but steady decrease in the strength of the materials, thus increasing the likelihood of sliding along slopes with gradients of 50° from the top to 5° at the toe (Figure 5).

**Figure 5.** Photograph of steep slopes the facilitated the movement of material down slopes

Slope and topography are seen as the main morphological factors that triggered the landslides of Azenge Hills in Nkomo District of Benue State. Field measurements indicated that the area is characterized by steep slopes ranging from  $17^\circ$  at the top to  $50^\circ$  at the base, deep valleys and generally rugged relief. This type of slope angle greatly affects the relative magnitude of the driving force on slopes. As the angle of potential slip plain increases, the driving force also increases, thus, landslides should be most frequent on steep slopes. A study of landslides that occurred during two raining seasons in California's San Francisco Bay area established that 75 to 80 percent of landslide activities is closely associated with urban areas on slopes greater than 15% or  $8.5^\circ$  [20].

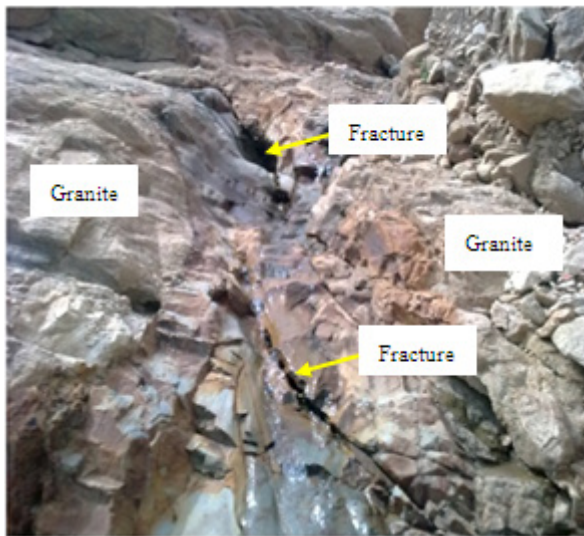
The rock types encountered in the area include gneisses, granites, dolerite dykes and basaltic rocks. Field evidence indicated the existence of granites, gneisses and dolerites lying uncomformably on basaltic rocks. The rocks in the study area have a general strike of 340°NW with a dip of 038°NE and were highly fractured. The deep and penetrating

**Figure 4.** Photograph of fractures that permit water to percolate and cause weathering and weakness of the rock unit

The presence of too many fractures on both the rocks that were moved and those in the adjoining area suggests fractures in the rock provided passage for weathering fluids (Figure 4). Fractures in the rocks acts as common translational slip planes. The presence of some clay minerals along some fracture zones in the rocks supports the view that the landslides occurred as a result of absorption of water by these clay minerals [14, 18].

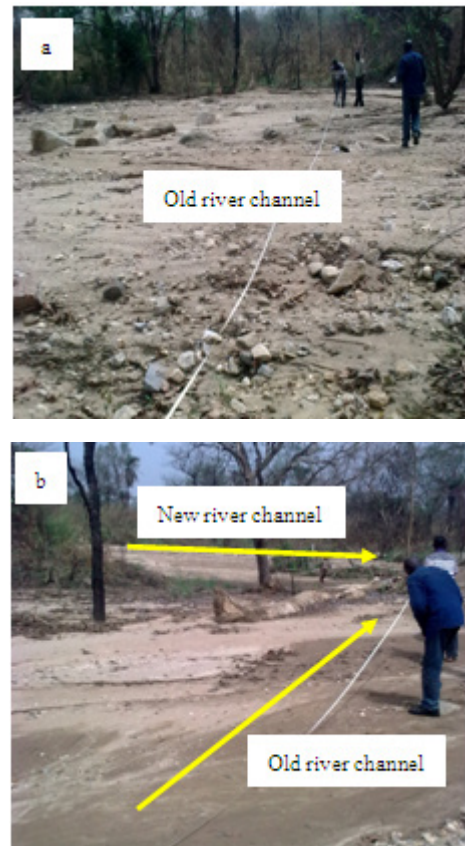
The materials from the slide were made up of fine debris to large fragments of the granitic and gneissic basement complex which has been intruded by dark coloured rocks believed to be volcanic rocks. The materials were deposited along the sliding path and the grain size of the materials decreases from the top to the bottom of the hill. The materials that were moved to the foot of the hill were deposited in the bed and flood plain of the then existing river with a width of 38.5m (Figure 6a). The deposition of the materials resulted in the diversion of the river course and development of a new river tangential to the old one (Figure 6b). Materials deposited were mainly small rock fragments, sand, mud and dead plant materials. The saturated soils following heavy rainfall acted as a lubricant for the materials to move rapidly and in mass down slope. The Azenge Mountain where the

**Figure 6.** Photographs showing (a) materials deposited on the then river valley and (b) the development of a new river valley tangential to the old one

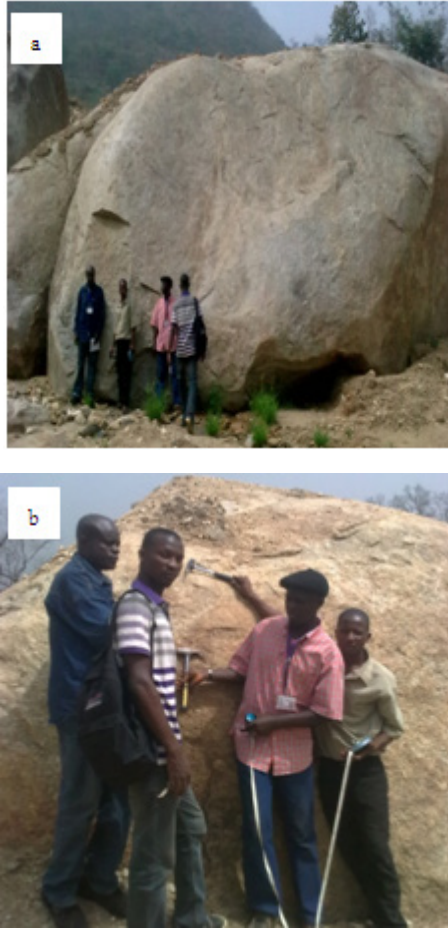
The landslide scar increased in width from the top (20m) to the base (75m) with an average depth of 58.73m and a total length of 950m. The largest boulders moved measured 15m long, 10.6m wide and 52.5m high (Figures 7a and b ). The sites of the 14 slides correspond to old fault planes

**Figure 7.** Photographs of boulders moved down slope (a) has a diameter of 71.2 m while (b) has a diameter of 88.5m. Size of materials moved decreases down the slope.

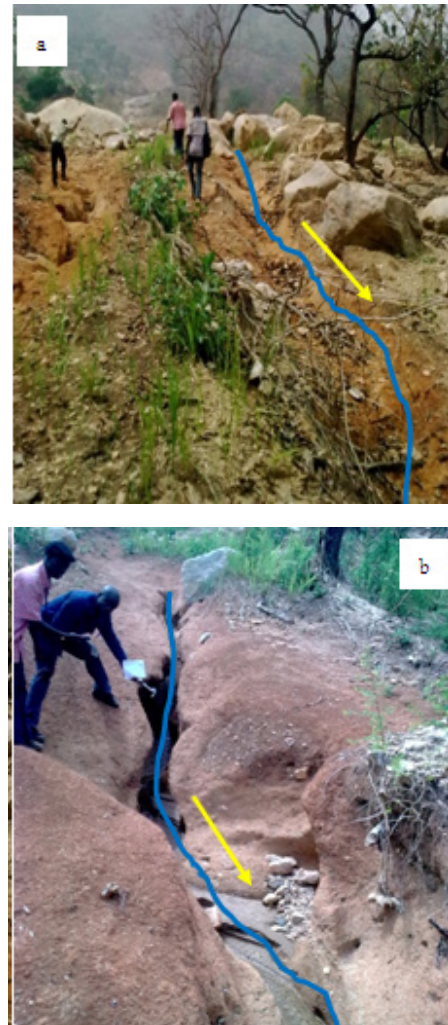
Human activities like farming and lumbering have been taking place within the area where the sliding occurred. The erosive action of the river and flood waters at the toe or foot of the hill was very visible as small and steep gullies appeared within the area where the landslides occur (Figures 8a and b).

**Figure 8.** Photograph of gullies produced (a) at the top and (b) at the foot of the hill. Note the that depth and width of the gullies increases from the top to the foot of the hill

The discharge of small springs along the slope and a stream along the foot of the hill must have produced failure as a result of the undercutting of the slopes, especially during the period (raining season) that the slides occurred. This undercutting serves both to increase the gradient of the slope, reduce stability and remove toe weighting which also reduces stability [19].

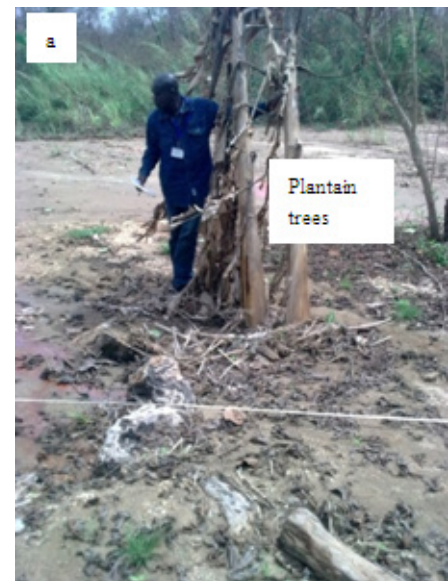
Field investigation equally showed that three rice farms, plantain and yam farms of about 200 square km and a large

number of palm trees and other economic trees were destroyed (Figures 9a and b).

**Figure 9.** Photograph of (a) plantain and (b) oil palm trees destroyed by the landslide
