2D ELECTRICAL RESISTIVITY IMAGING INVESTIGATION ON CAUSES OF ROAD FAILURE ALONG KUTIGI STREET, MINNA, NORTH CENTRAL, NIGERIA

| Joshua Ebuga Peter ^{1*} | Rafiu A.A.¹ | Udensi E.E.¹ | Salako K. A.¹ | Alhassan U. D.¹ | and | Adetona A.A.¹ |

¹Federal University of Technology Minna | Department of Physics | Minna | Nigeria |

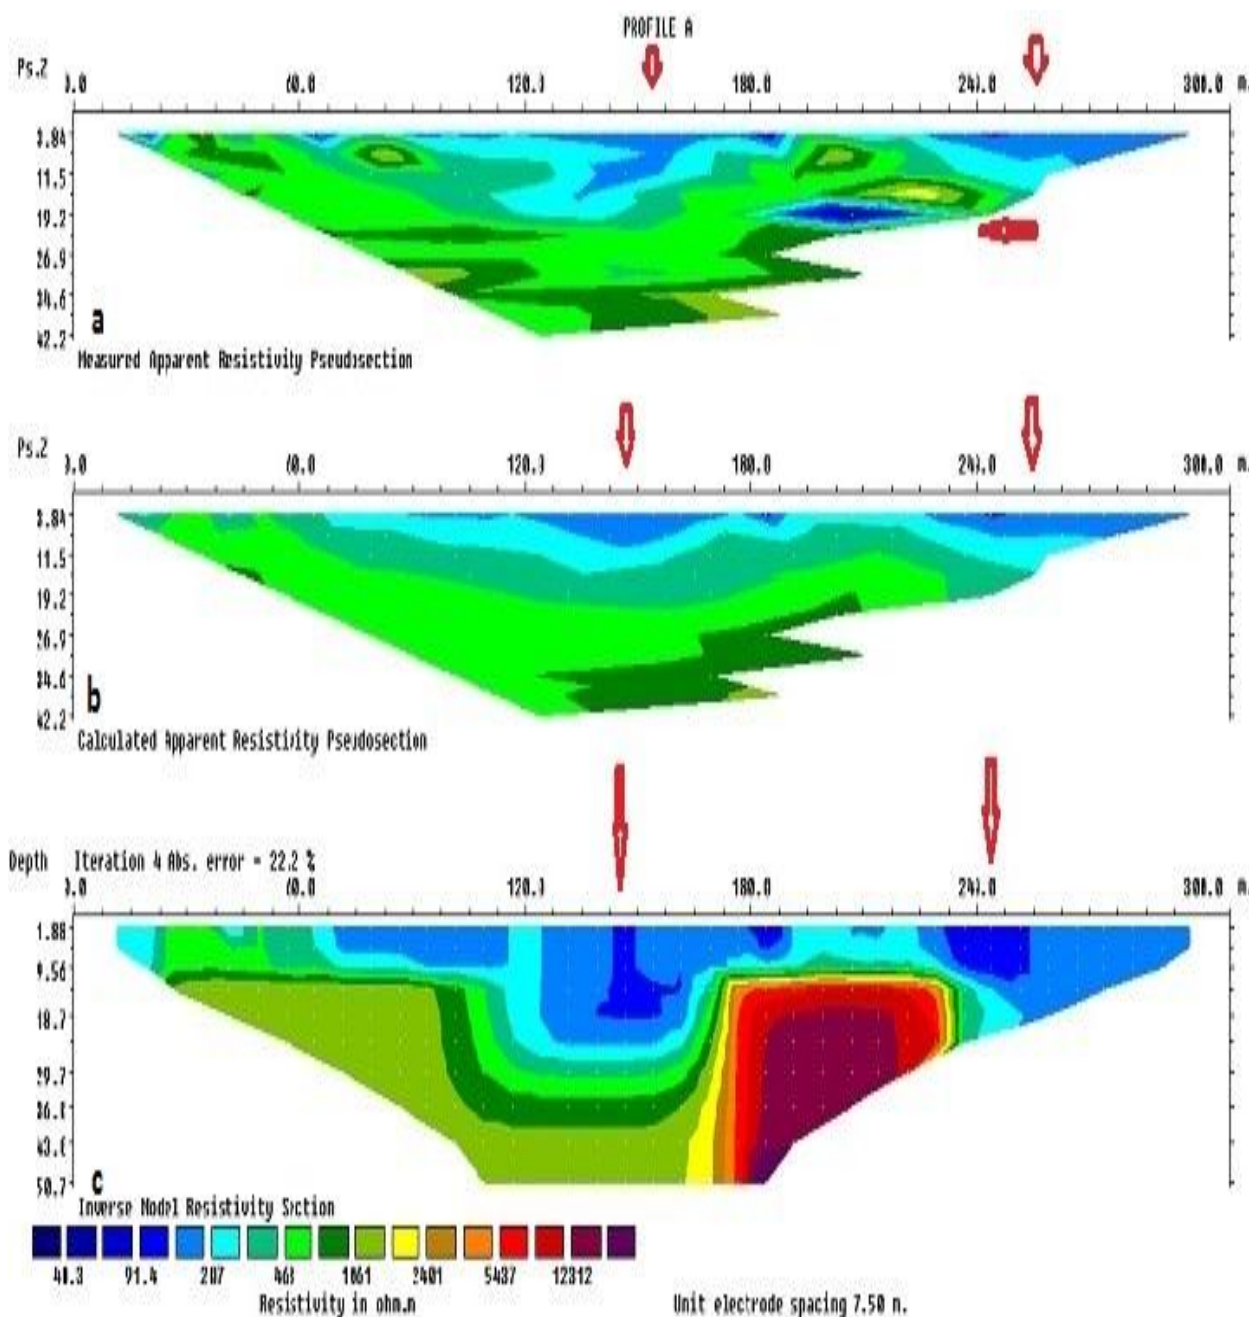
Figure 3: Pseudo-section plots showing (a) measured apparent resistivity of profile A (b) calculated apparent resistivity of profile A (c) inverse model resistivity section of profile A.

Figure 3(a) represents the Pseudo-section from the apparent resistivity measurement along profile A. It shows a low resistivity value ranging from $9.75 \Omega\text{m}$ – $91.40 \Omega\text{m}$, between two major regions at distances ranging from 120 m – 190 m and 225 m – 300 m along the transverse to a depth of 3.84 m – 19.20 m and 3.84 m – 11.50 m respectively. Figure 3(b) is a Pseudo-section generated from the calculated apparent resistivity values showing relatively low resistivity values in two region along the traverse similar to the position of the result obtained in figure 3(a).

Figure 3(c) is the inverse model which reveals the resistivity sections along the transverse. Two distinctive zones were observed with low resistivity values along profile A. At a distance between 122.5 m – 130.0 m along profile A, low resistivity values ranging from $19.25 \Omega\text{m}$ – $107.0 \Omega\text{m}$ to a depth of 19.2 m from the top soil were observed. Also at distances between 232.50 m – 252.50 m , low resistivity values ranging from $9.25 \Omega\text{m}$ – $115.30 \Omega\text{m}$ to a depth of 11.50 m from the surface of the profile was observed.

Low resistivity values, less than 200 Ωm observed in regions of both profiles comprises of expansive clay and sandy clay materials which have the tendency of absorbing water [6]. These makes them to swell and eventually collapse under imposed wheel load stress which leads to failure. The stable regions of the road have considerable high resistivity value greater than 200 Ωm , mostly laterite materials [6].

Geo-electrical attributes of the road subsurface along Kutigi Street were examined to ascertain the causes of its failure. In profile A Figure 3(c), low resistivity values were observed ranging from 9.25 Ωm – 115.30 Ωm to a depth of 11.25 m from the topsoil along the profile. In profile B, low resistivity values were observed in Figure 4(c) ranging from 5.20 Ωm – 25.6 Ωm to a depth of 11.25 m from the topsoil along the profile.

Other contributing factors such as inadequate drainage system, lack of maintenance, thin pavement coating of the road, and poor construction materials are factors resulting to eventual failure of the road. Regions of the road with sandy and clayey materials should be excavated from the subsurface to a depth of 4 m – 6 m from the top soil of the road and replaced with competent fill materials.

Adequate drainage system should be provided for the road to avoid the long time suspension of water on road pavement as this weakens the molecular force holding the particles of the pavement together.

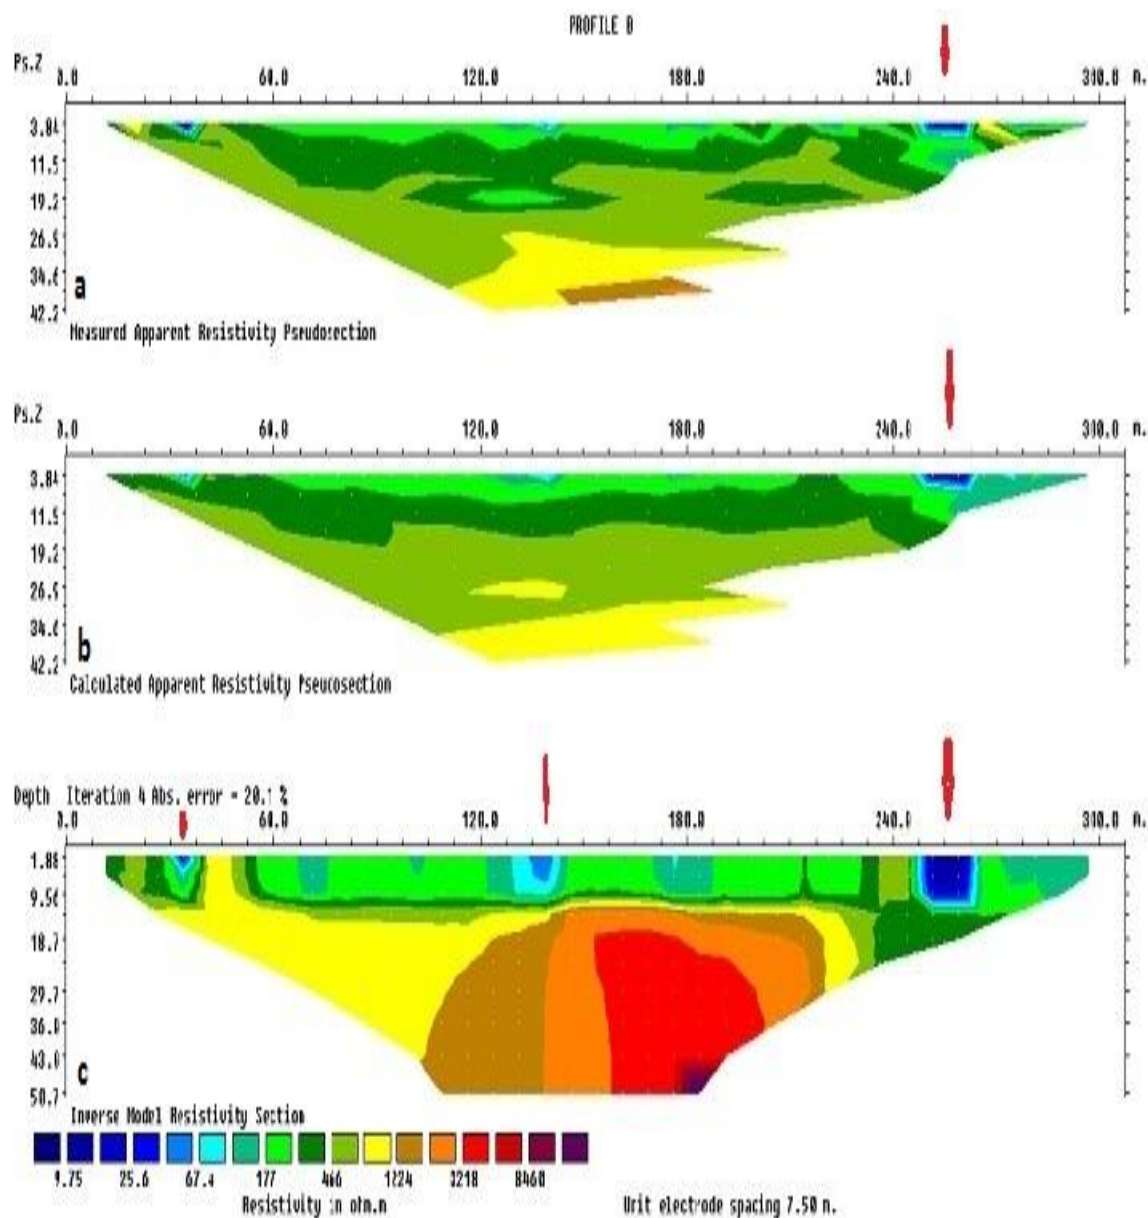
Figure 4: Pseudo-section Plot showing (a) measured apparent resistivity of profile B (b) calculated apparent resistivity of profile B (c) inverse model resistivity Section of profile B.

Figure 4(a) is a Pseudo-section from the apparent resistivity measurement along profile B. It shows a low resistivity value ranging from $25.60 \Omega\text{m}$ – $67.40 \Omega\text{m}$, between distances of 247.50 m – 262.50 m along the profile to a depth of 7.50 m from the surface of the profile. Figure 4(b) represents a Pseudo-section established from the calculated apparent resistivity values showing relatively low resistivity values in the same region along the traverse similar to the position of the result obtained in figure 4(a).

Figure 4(c) represents the inverse model showing resistivity sections along the profile B. Several zones along the profile exhibit slightly low resistivity values with most area along the profile having resistivity greater than 200 Ωm . Three distinctive zone with very low resistivity values were observed at a distances ranging from 30.0 m – 37.50 m, 135 m – 142.50 m and 247.50 m – 277.50 m to a depth of 3.84 m, 9.54 m and 11.25 respectively.

Low resistivity values below 200 Ωm was obtained in some regions of profile A and B, which indicates the presence of expansive clay and sandy clay material beneath the subsurface of the road pavement. These clay materials are unsuitable as subgrade materials for road pavement, as it consistently expand and contract under varying weather condition. The frequent expansion and contraction of these subgrade material leads to cracks on the road pavement and eventual failure of the road. Also slightly high resistivity values greater 200 Ωm were observed along the profile A and B indicating the presence of laterite material which is good subgrade material for road pavement.
