INFLUENCE OF GEOLOGY AND HYDROGEOLOGICAL CONDITIONS ON THE PERFORMANCE OF A ROAD PAVEMENT BETWEEN SHANGO AND CHANCHAGA ALONG MINNA –LAMBATA ROAD, CENTRAL NIGERIA

Abstract

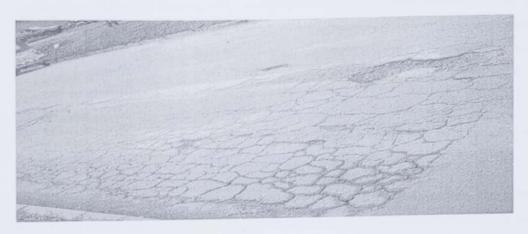
1980; Okabue and Uma, 1988) that geological and hydrogeological conditions underlying a highway route are important factors in the effective performance of the road. Analysis of the impact of geology on the effectiveness of a portion of a highway in Minna is been made in this paper. A particular point opposite the Public Works Nig. Ldt yard (Tungan-Goro-Chanchaga) experiences frequent failures as seen in figure 1.

Figure 1 A failed portion of the studied road

The incessant failures of the portion of the road opposite the PW gate along Shango -Chanchaga dual carriageway Minna is linked to the geology/hydrogeology of the area. This portion of the road is built on weak sub-grade (jointed, fractured and weathered schist) that has lost its ability to carry load. The road is at a low elevated area with an accumulation of groundwater seeping out. Majority of the seepages have become obstructed leading to rise in water table under the highway due to increased groundwater storage. This results in the base course being prone to fast disintegration. The schist has weathered to plastic clayey materials that absorb water, swells and expands in the wet period and contracts during the dry period. This has led to longtime wetting of the base and sub-base materials during the wet season. The provision of adequate sub-base drainage facilities will help minimize in the subgrade

The hydrogeologic conditions together with the poor drainage that have resulted to the lowered strength of the subgrade could be responsible for the failed pavement. The significance of understanding the geology/hydrogeology in selection, design, construction and wellbeing of highways therefore, should not be under estimated.

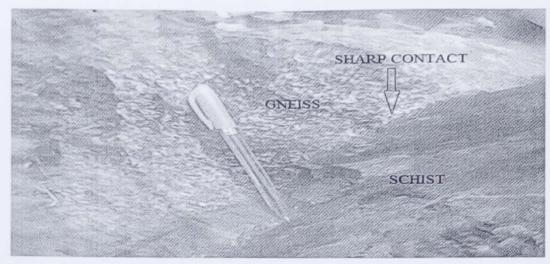
The geology of Minna area reveals that the schist has been intruded in places by the older granite (figure 2). The emplacement of the older granite has led to intense jointing and fracturing of the schist. The schist is fine grained, foliated and dips at about 28°W. Most of the drainages cut the narrow valley and water moves from the hills to the valley during raining season. The schist is mostly exposed along these river channels (River Chancgaga). Drainage pattern is the trellis while the major river found along the road is the Chanchaga River which is a tributary of the Kaduna River.

Figure 2: Schist

intruded by granite gneiss in Minna area

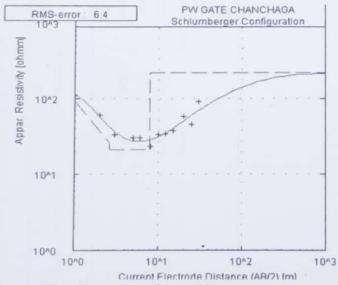
Figure3: Subsurface geology of the problem area

No	Res	Thic	k Depth	
1	146.6	0.7	0.7	
2	26.0	1.9	2.6	
3	21.2	5.2	7.8	
4	219.2		-,-
