Corrosion monitoring in Nigerian petroleum industry : A case study of Kaduna petroleum refinery

J O Odigure, A S Abdulkareem, O D Adeniyi & O Abdullahi

Chemical Engineering Department, Federal University of Technology, Minna, Nigeria

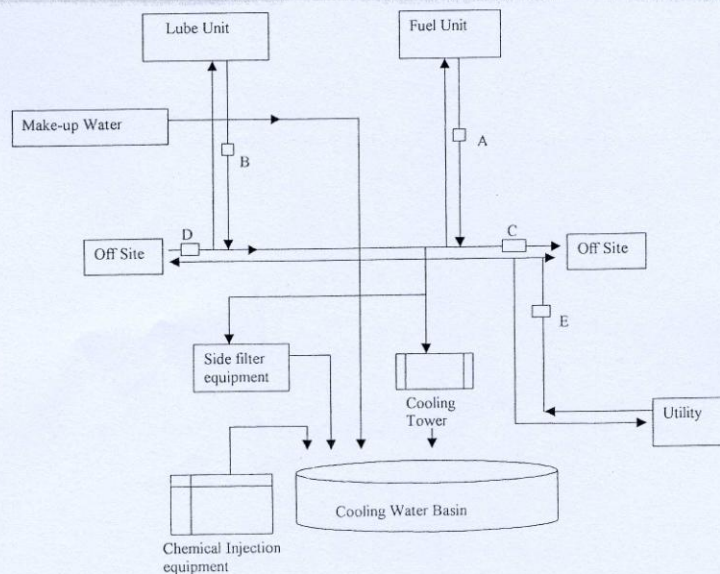
Fig. 1—Schematic diagram showing the points of coupon installation along the cooling water pipeline

Five different points were considered along the cooling water pipeline of a petroleum refinery. These five points were named A, B, C, D, and E (Fig. 1). The coupons were cleaned and weighed and the weight recorded. Three coupons were then installed inside the pipeline at the top, middle and bottom at each of the points using coupon station holder to hang them so that there was no contact with the pipeline. After several days the coupons were removed and weighed again. The rate of corrosion was then determined using the formula:
