DEVELOPMENT OF A GPS-GIS-BASED ROAD SIGNAGE MANAGEMENT SYSTEM FOR SELECTED ARTERIAL ROADS

Four primary arterial roads in Ilorin metropolis, Kwara State, Nigeria are selected for the study. The roads are Ibrahim Taiwo road, Unity road, Murtala Mohammed road and University of Ilorin Main Campus road.

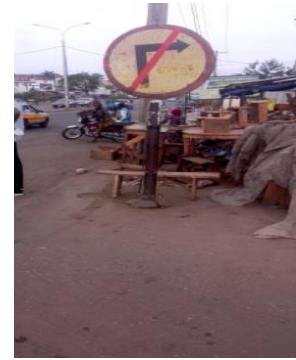
Figure 1 Signage at 0+145m on Unity Rd

While some of the signs are rated "Good", some others are rated 'Fair' or 'Critical'. Figures 1 and 2 are samples of the

traffic signs rated 'Good' and are located at Chainage (Ch) 0+145m and Ch 0+175m on Unity Road respectively; their letterings and signs symbols are legible and the colors considered as bright.

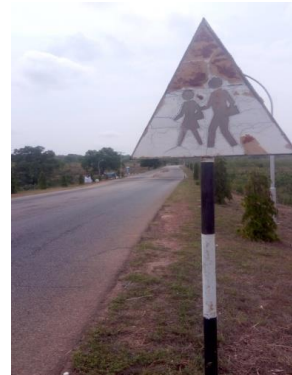
Figure 3 Signage at 0+075m on Murtala Moh'd Rd

Signs on Figures 3 and 4 are classified as 'Fair' (maintenance need is futuristic) needing maintenance in the future. Their colors and legibility are already poor and need to be attended to in the very near future. Figure 5 is a signage at Ch 0+052m on Ibrahim Taiwo Road. The sign mounted on the post has been removed and rated as a 'Critical' traffic sign as it is blunt and does not convey any message; therefore needs immediate maintenance. So also is the sign on Figure 6 at Ch 2+252m on University of Ilorin roadway rated 'Critical' sign. Figure 7 is a defaced signage at Ch 1+038m on Murtala Mohammed Road, its condition is classified as critical and needs urgent maintenance.

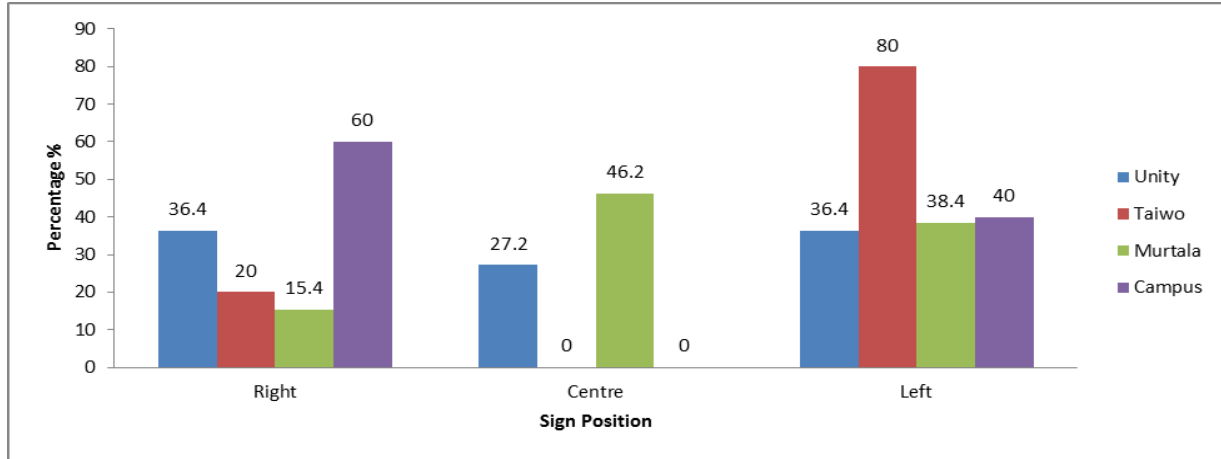
Figure 8 Comparison of the Sign Position

Figures 8 – 12 display a comparison in percentages of the different sign post factors between the four studied roads. Figure 4 shows that 81.8 % of the signages along Unity road have no defects while all the signages along Taiwo road have one defect or the other. Forty percent of the sign posts along Taiwo road have their mounted heads removed making it impossible to identify what type of information they are to convey. In Figure 12 all the signages along Taiwo road are 'Critical' whereas 81.8 % of the signages along Unity road are rated 'Good'.

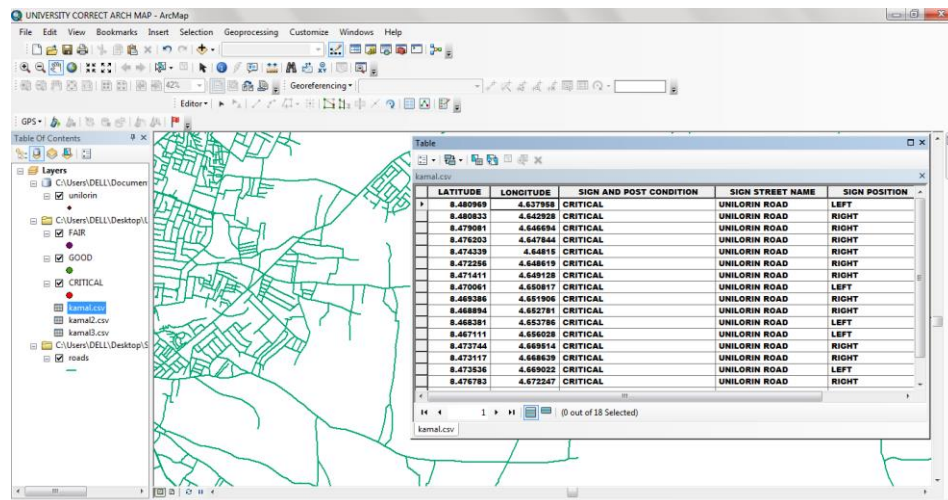
Figure 15 Attribute of collected data for Critical Traffic Signs at University of Ilorin Road

The graphical display of the sign locations assists in the maintenance gang deployment and maintenance schedule. Figures 15 and 16 respectively show the outcome of the spatial search query for the attribute tables of 'Critical' traffic signs on the University Road and the 'Good' traffic signs on the same road.
