CONTAMINATION INVESTIGATION USING GEOELECTRICAL RESISTIVITY
AND HYDROGEOLOGICAL DATA: A CASE STUDY OF REGOLITH
GROUNDWATER AROUND AGWAN-NEPA DUMPSITE, KEFFI, NORTH-
CENTRAL NIGERIA

Unuevho, C.^{1*}, Ancho, M.¹, Onuoha, K.M.², Amadi, A.N.¹, Ogunbajo, M.I.¹, and
Alkali, Y.B.¹

¹DEPT OF GEOLOGY, FEDERAL UNIVERSITY OF TECHNOLOGY, MINNA
²DEPT OF GEOLOGY, UNIVERSITY OF NIGERIA, NSUKKA

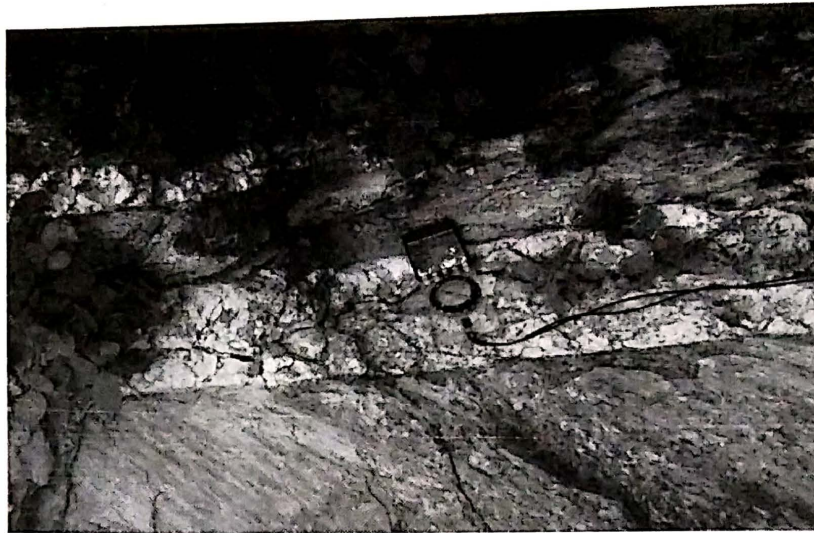
Figure 4. Mineral bearing pegmatitic vein $N8^{\circ}50'05''$; $E7^{\circ}51'38.5''$ (within Kofar Kokona)

Pegmatitic veins bearing yellowish minerals with metallic lustre (probably sphalerite, pyrite, chalcopyrite, - pathfinder minerals for gold) are hosted in the schist (Fig. 4).

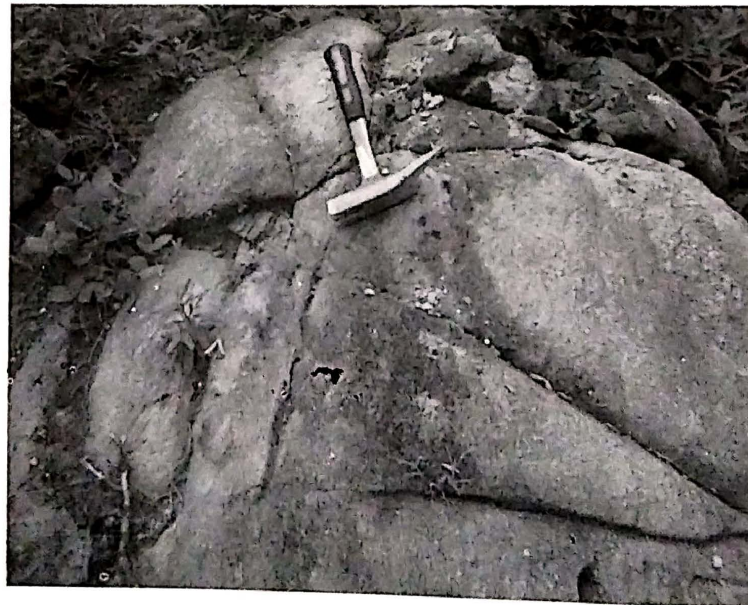
Figure 5. Conjugate set of joints observed on granite outcrops ($N 8^{\circ} 51' 01''$; $E 7^{\circ} 52' 10.8''$)

The rocks are commonly jointed (Fig.5). The principal joints trend NNE-SSW, and NNW-SSE. They constitute a conjugate joint set. Some of the schist outcrops bear micro-faults (Fig.6).

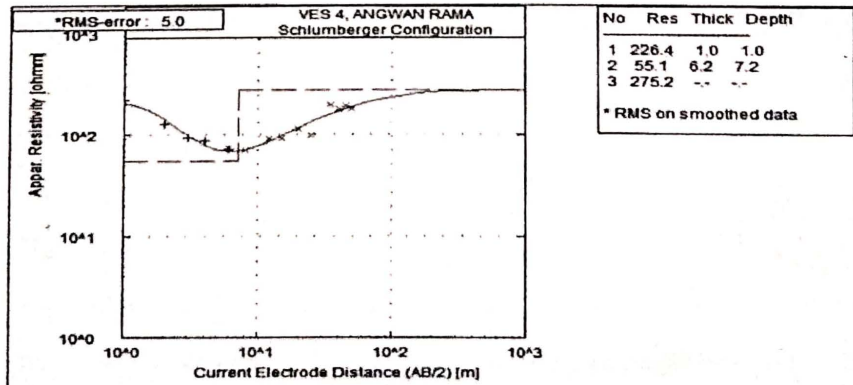
Figure 7. Representative H-type curve for Agwan-Nepa

The geoelectric curves obtained were mostly H-type, indicating top soil,

weathered basement and fresh basement. Figure 7 is representative of these curves.

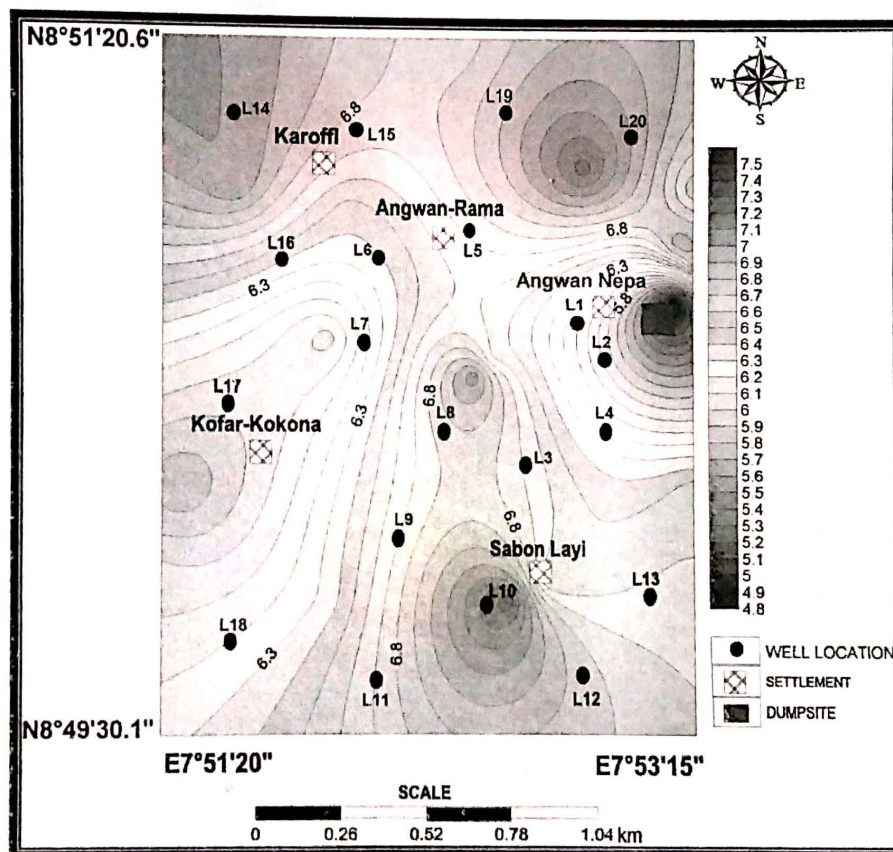
Figure 16. pH value contour map of Angwan-Nepa dumpsite and its environs

in groundwater table elevation values within the dumpsite vicinity. Acidity decreases generally away from the dumpsite (Fig.16). High acidity level (4.8-4.9 pH) at the dumpsite is attributed to the effect of incessant burning on the heap of junks of miscellaneous metals. The World Health Organisation (WHO, 2011) and the Nigerian Standard for Drinking Water Quality (NSDWQ, NIS554:2007) uphold

pH range of 6.5 to 8.5 as limits for water fit and safe for drinking. The pH values (5.2-6.5pH) at 1.5Km distance range west and south of the dumpsite reflect that groundwater in the regolith aquifer in the area is contaminated from a point source constituted by the dumpsite. The pH values in the groundwater flow convergence areas ranges from 6.8 -7.0. This indicates dilution effects in these areas.
