# INTEGRATED GEOLOGY, MINERALOGY AND GEOCHEMISTRY INVESTIGATIONS OF THE MINNA-TEGINA-MAKERA ROAD NORTH WESTERN NIGERIA: IMPLICATION ON FAILED PORTION

**\*Alabi A. A., Unuevho C., Jimoh M. O., Akande W. G., Ejepu S. J., Asema A. I.**

Department of Geology Federal University of Technology

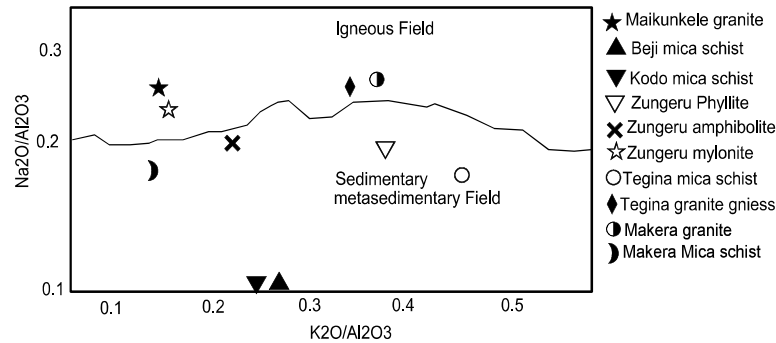
Geochemical binary plot of  $\text{Na}_2\text{O}/\text{Al}_2\text{O}_3$  versus  $\text{K}_2\text{O}/\text{Al}_2\text{O}_3$  show that the mica schist, phyllite and amphibolite schist are of sedimentary provenance while granite and granite gneiss are of igneous provenance (Figure 7).

Figure 7:  $\text{Na}_2\text{O}$  versus  $\text{K}_2\text{O}$  plot for study area rocks (after Garrels and Mackenzie, 1971)
