# DEVELOPMENT JOURNAL OF SCIENCE AND TECHNOLOGY RESEARCH (DJOSTER)

Volume 3, Number 1, 2014

## AN EVALUATION OF MUNICIPAL WATER SUPPLY IN BOSSO, NIGER STATE USING GEOSPATIAL TECHNIQUES

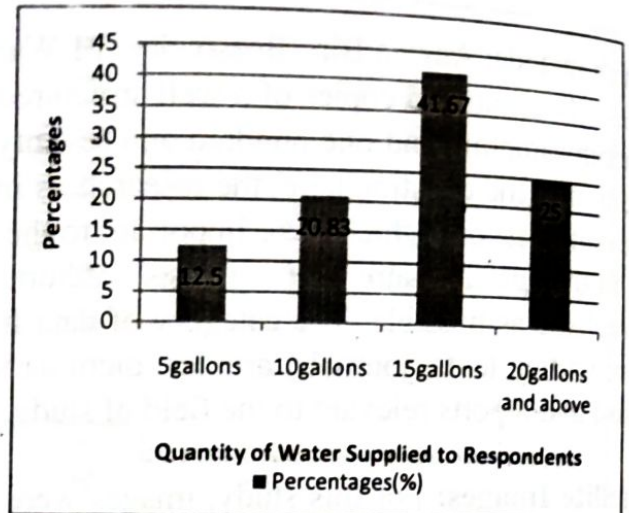
**Fig. 5: Quantity of Water Supplied Respondents**  
Source: Authors' Field Work

Figure 3 above shows the quality of tap water using the colourless, tasteless and odourless parameters. The percentages of all the parameters used are high. This is an indication that even though the distribution of tap water is low the quality of the water is high. Figure 4 above reveals the frequency of water supplied. Only about 16.67 percent of the respondents receive tap water daily, then 29.17 percentage receive water twice a day, 20.82 receive water three times a day while 16.67 receive water every other day, the percentage of the respondents that receive water once or twice in a period of weeks or months as the case may be is 16.67 percent. Figure 5 above points out the quantity of water supplied to the respondents in terms of gallons is highest for 15gallons

and above, followed by 20gallons and above, then 10gallons and 5gallons respectively. Figure 6 shows that the pressure of water flow when supplied is high (41.67%), while for other respondents it flows fairly well. The flow is poor in some areas and flows in drops in other areas. Figure 7 indicates that about 51.22 percent of the respondents are usually supplied for at least 6hrs/day while 42.68percent are supplied for about 2-5hrs/day while only few respondents are supplied water for a whole day.

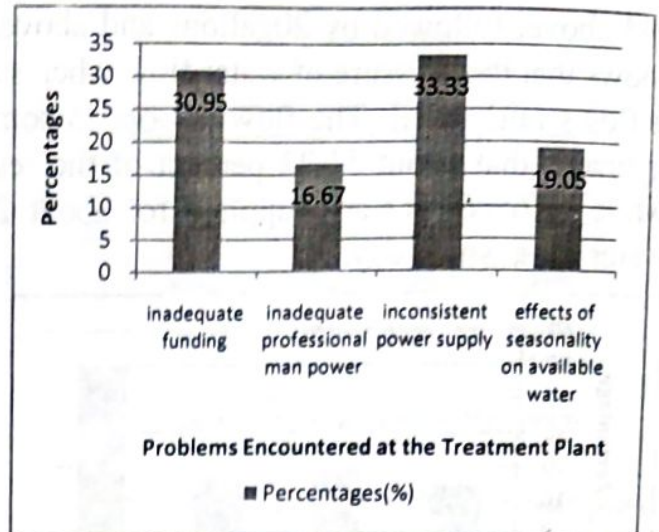
**Fig. 13: Problems Encountered at the in Treatment Plant**

Figure 8 shows that the problems of water supply are associated to inadequate management, poverty which is attributed to the inability of consumers to pay up their water utility bills, topography which accounts partly for insufficient taps in Bosso and generally all the problems pose negative effects on the water supply. Figure 9 above points out that seasonality affects both the volume of water and the quality of the water which implies that during the rainy season the volume increases and reduces during the dry season similarly, the pollution and deposition of sediments that contaminate the water from the source points is higher during the rainy season than during the dry season. Turbulence and turbidity of the water is also higher during rainy season. Figure 10 reveals that the expansion of the distribution system will improve water supply with the highest percentage. This is because the existing system is inadequate for the growing population of the area. The next is improved management, subsidized cost of water bill and construction of reservoirs for places that pipes might not be able to be laid due to the nature of the terrain. Figure 11 above indicates that a higher percentage of the respondents said that the topography of the area is a reason why there are insufficient taps, followed by poor maintenance which can be attributed further to the reasons like old laid down pipes, broken pipes etc.; negligence by the consumers, which include their inability to report breakages etc. Other respondents believed that all the above mentioned reasons can be attributed to the insufficient taps in Bosso. Figure 12 above indicates that the source of dissipated water is both Tagwai dam and Bosso dam Tagwai dam. While others said it was Tagwai dam alone which might be attributed to the fact that it stores more water and is more functional and reliable, then Bosso dam. Figure 13 above signifies that inconsistent power supply is a major problem encountered at the treatment plant, followed by inadequate funding, seasonality and inadequate professional manpower.

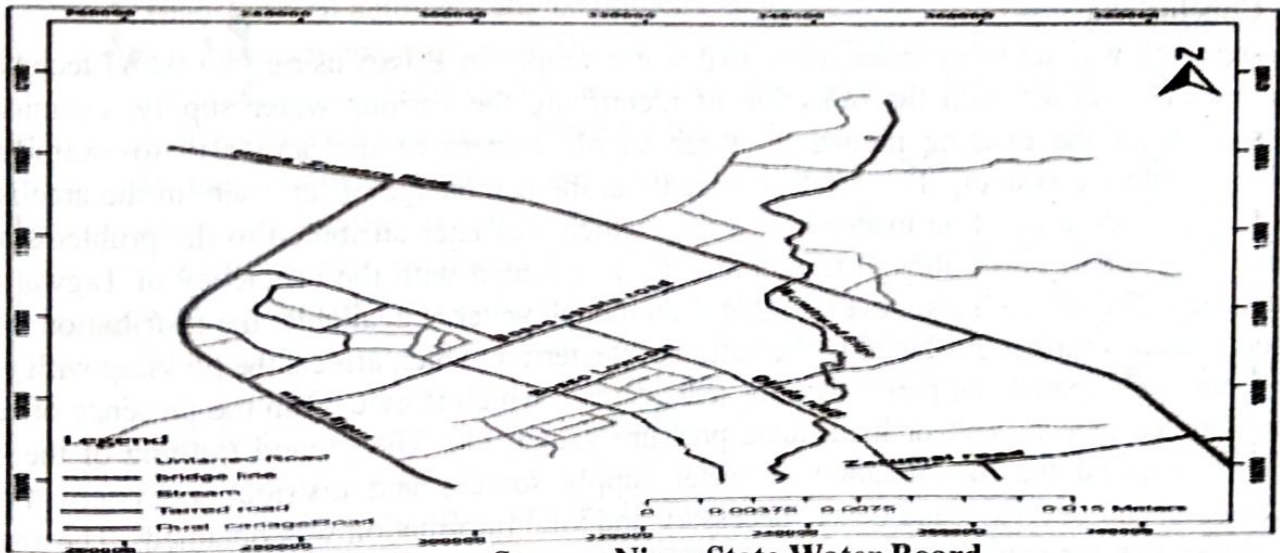
Fig. 21: Distribution Map of Bosso. Source: Niger State Water Board
