IMPACT OF HIGHWAY ALIGNMENT ON URBAN FLOODING IN MINNA, NIGERIA

***O. D. Jimoh and P. N. Ndoke**

Department of Civil Engineering

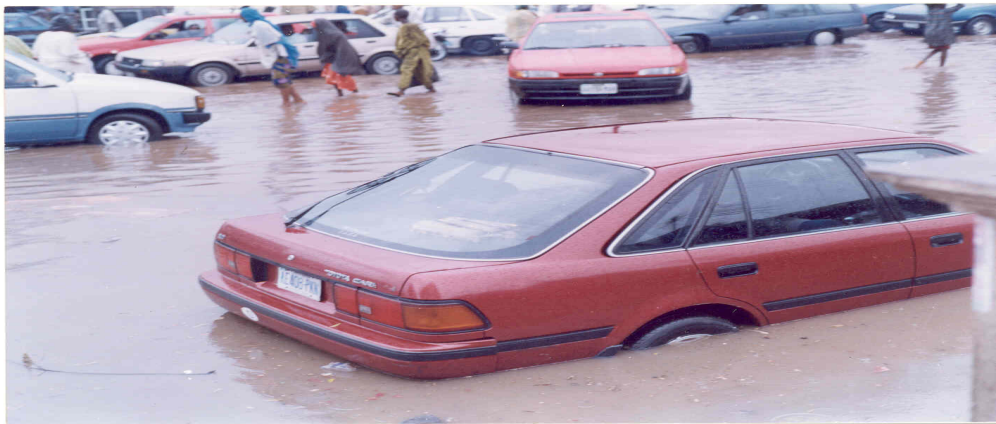
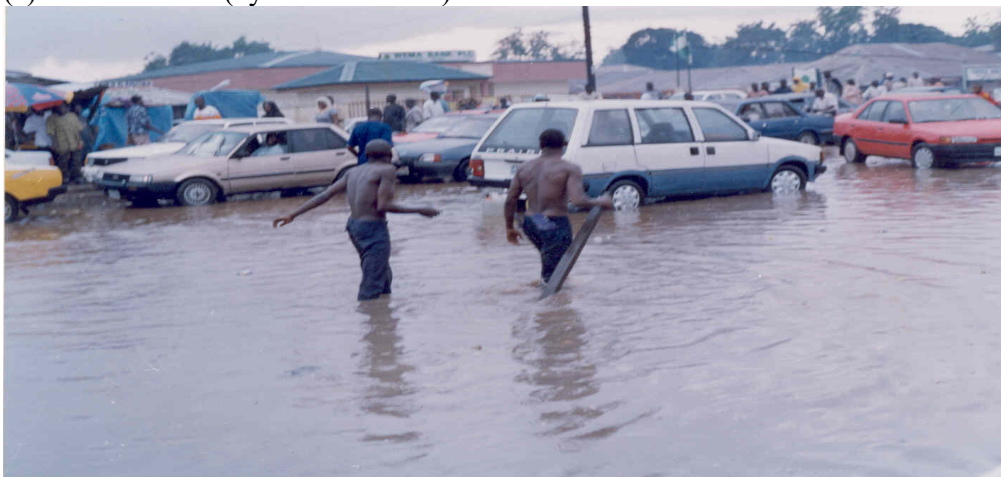
(a) Left hand side (by Fototek house)

(b) Right hand side of the road

Plate 1: Flooding of Booso Road – approaching Mobil roundabout in September 2004
