## **ASSESSMENT OF THE GULLY EROSION AND DISASTER RISK IN RAFINGORA AREA OF KONTAGORA, NIGER STATE, NIGERIA**

Dukiya J.J., Muhammed M., Ojoye S., Musa J., and Morenikeji G.

Center for Disaster Risk Management and Development Studies,

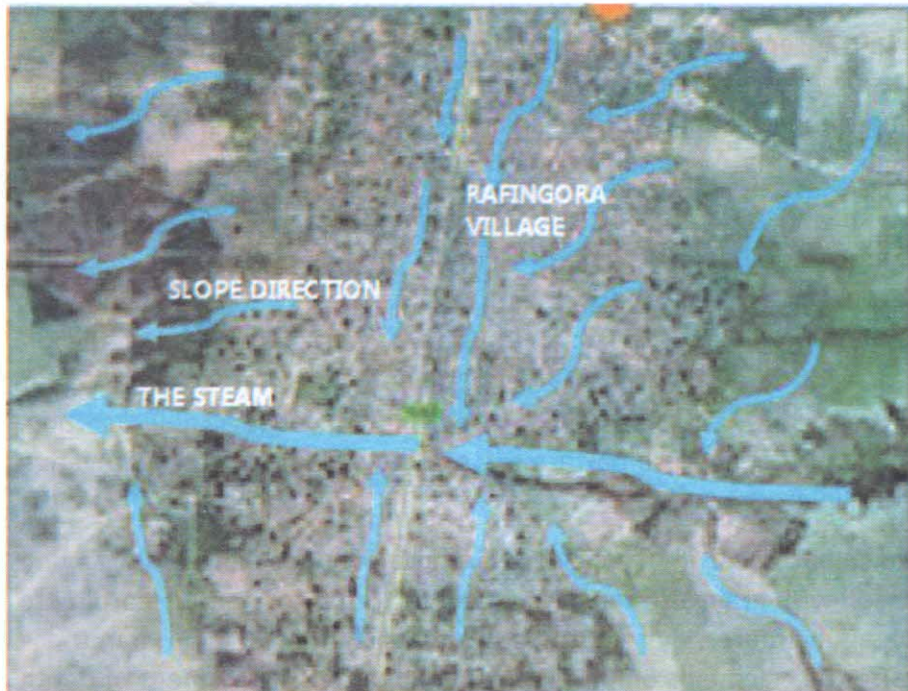
The topography of Rafingora and Babarami is of a gentle slope from all the directions toward the central part of the village. The nature of the soil surface enhances the development of rivulets and tributaries that are filled with sand flow from the northeastern and northwestern parts of the village up hills. These elevated areas of about 300m above sea level are highly degraded due to overgrazing and farming activities. The entire village is well drained with evidences of dry valleys as illustrated in Fig. 2. This is in consonant with the works of Michaelides et al (2012) and Turnbull et al (2011) that long slopes (especially those without adequate vegetal cover) are more susceptible to very high rates of erosion during heavy down pour than shorter, less steep slopes. Steeper terrain is also more prone to mudslides, landslides, and other forms of gravitational erosion processes.

The field observation further reveals the pattern and the rate at which the erosion activities are changing the morphology of the entire area. For instance, the eroded channels from the hills at the northwestern part of the village were less severe to an average breadth and debt of about 2.6m and 1.6m respectively. These channels toward the built up areas were later widely distributed forming a network of various channels with breath and height of about 4.0 to 1.8m within the village. At the eastern part of the village, the erosion activities were so prominent and severe, and this was where lives and houses were lost to flash flood in July, 2018.

Figure 2. slope analysis of Rafingora village.

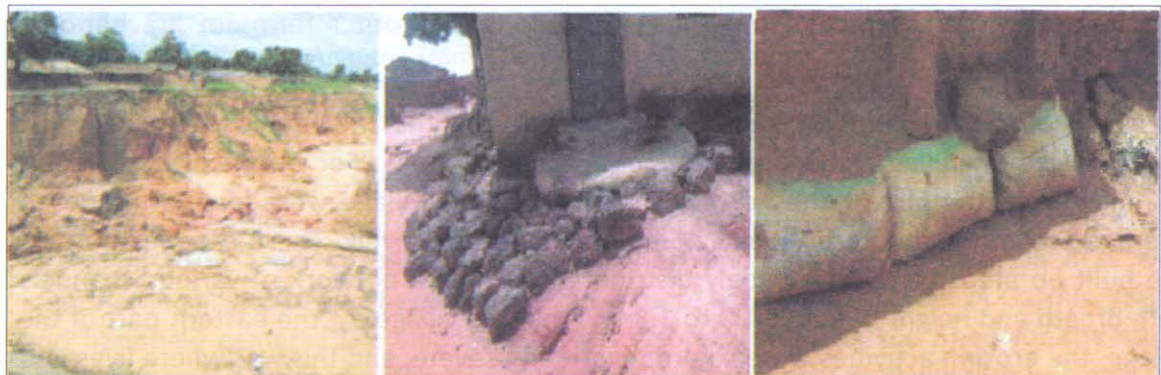
The inhabitant of Rafingora majorly lives in mud houses. The physical examination and oral interview of the people revealed that the walling materials of their buildings were excavated from the major stream valley within the village. In other scenario, sand stone were also excavated from the stream valley to buttress their building foundations to mitigating the impact of gully erosion as revealed in Fig. 3. The only consolidated sand stone available in the area is been excavated by the villagers and this has made the entire area more vulnerable to gully erosion. The farming system is dictated by the short duration of the raining season of about three months effectively. Amidst of this, the villagers still depend on fuel-wood for their domestic energy supply. Apart from mango trees and other trees like lime, the entire area is covered with patches of grasses. There is therefore no cover crop after rain-fed harvest to checkmate erosion activities.

Figure 3. Gully erosion and sandstone used as foundation embankments in Rafingora.

- i. The people residing in the eastern part of Rafingora should be evacuated to a more stable land so as to avoid the next unforeseen disaster associated with landslide
- ii. Mining of building material and excavation of sand stone from the drainage channels should be totally discouraged as more erosion problems are being created by so doing.
- iii. Retention walls and effective artificial drainage system should be constructed within the village to reduce the impact of runoff, while advocating for special tree planting.

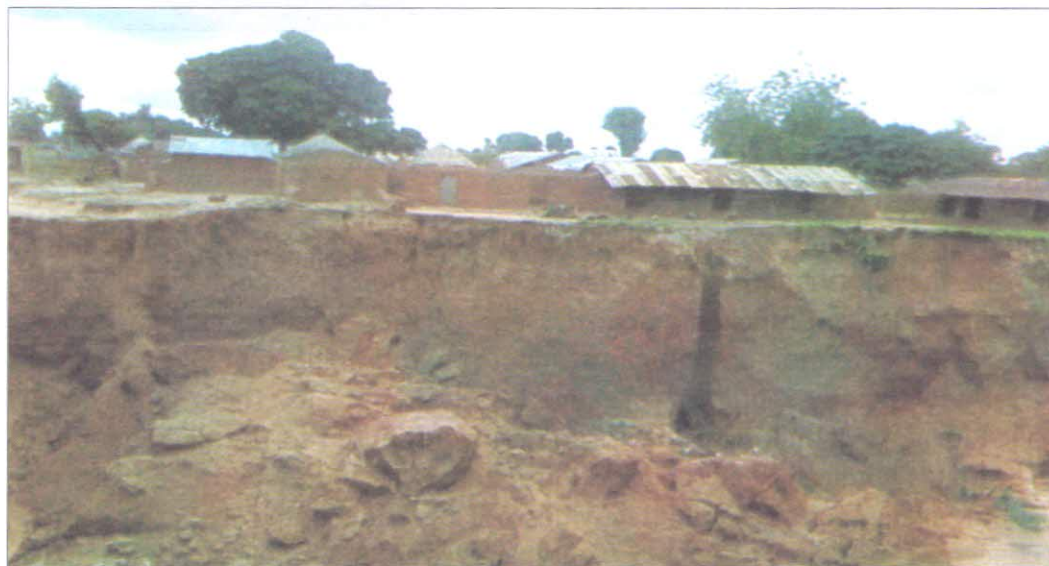
One of the major challenges in the built environment where gully erosion is prevalent is landslide and soil creep that often threaten housing structures and other infrastructural facilities. The sporadic expansion of the major stream valley in the village has claimed lives and buildings, and still continues to threaten the livability of the existing ones. More than forty (40) houses are less than one meter (1m) away from the brim of the stream gully. Although, within the community there are areas with less severity of erosion, but the eastern part of the village where land sliding is more active, all houses situated close to the erosion channels are highly vulnerable as revealed in Fig. 4.

Figure 4. Parts of those houses that are more vulnerable to severe gully erosion.
