IMPACTS OF QUARRYING ON LAND AND SOIL IN KAMPANI KIRIYA COMMUNITY NEAR ZUNGERU, NORTH-CENTRAL NIGERIA

^{1*}Nwafor, V.C. and ² Alkali, Y.B.

¹ & ² Department of Geology, Federal University of Technology, Minna, Niger State Nigeria

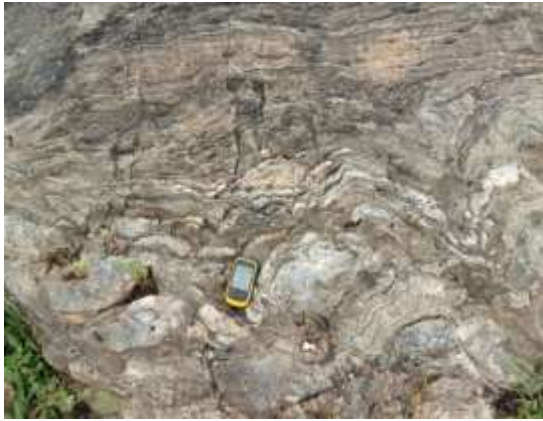
Plate I: Highly foliated dark-grey schist with medium-coarse grained texture

Geological field mapping shows that the study area consists of schist which has been intruded by large bodies of granitic rocks as shown on the geological map (Figure 3). The schist occupies more than 80% of the study area and occurs as low-lying rock units. It is dark grey in colour, medium to coarse grained, highly foliated and consists of feldspar, quartz and mica (Plate I). In some locations, the schist has been greatly deformed and tilted and dips up to 50° while in others they have been greatly weathered displaying remnants of previously more extensive assemblages. Granitic rocks of the Older Granite suite account for less than 20 % of the study area and occur as batholiths which are massive, hilly and elongated acidic rocks (Plate II) containing a lot of quartz veins. The rocks are dark grey in colour, fine to medium grained, weakly foliated, consist of light and dark coloured minerals, and form fairly prominent topographic features which resemble the schist ridges.

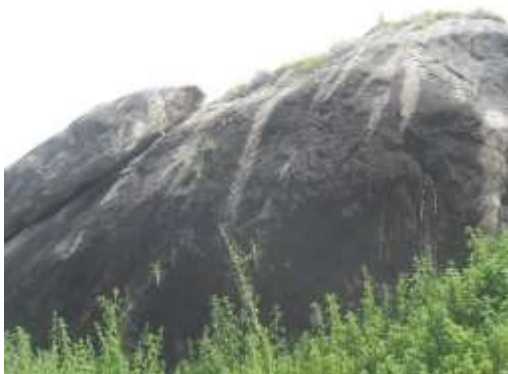
Plate II: A massive, hilly, elongated and exfoliated granitic rock with quartz vein cutting across

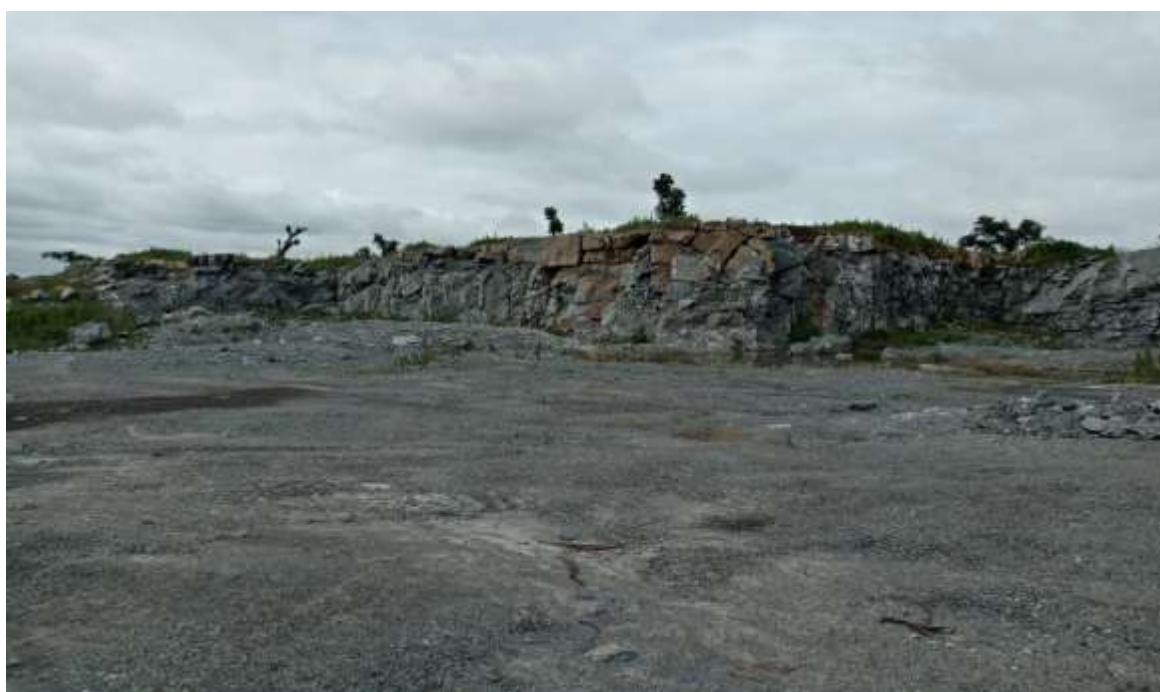
Plate IV: Destruction of natural landscape due to quarrying activities at Kampani Kiriya

Destruction of landscape and loss of topsoil: The activities of quarrying in the study area, have led to the destruction of the natural landscape (Plate IV). Clearance of vegetation also led to soil erosion down the slopes. Several gullies and trenches had been created along the roads linking the quarry sites as a result of persistent and sustained removal of the top soil. No measures have been put in place by the quarrying company to reclaim the degraded lands as a result of their activities.
