Geospatial Evaluation of Building Facility in Oyo State, Southwestern Nigeria

Research Article

How to cite: Jimoh et al., (2022). Geospatial Evaluation of Building Facility in Oyo State, Southwestern Nigeria. *International Journal of Environment and Geoinformatics (IJEGEO)*, 9(2):139-145. doi: 10.30897/ijegeo.811277

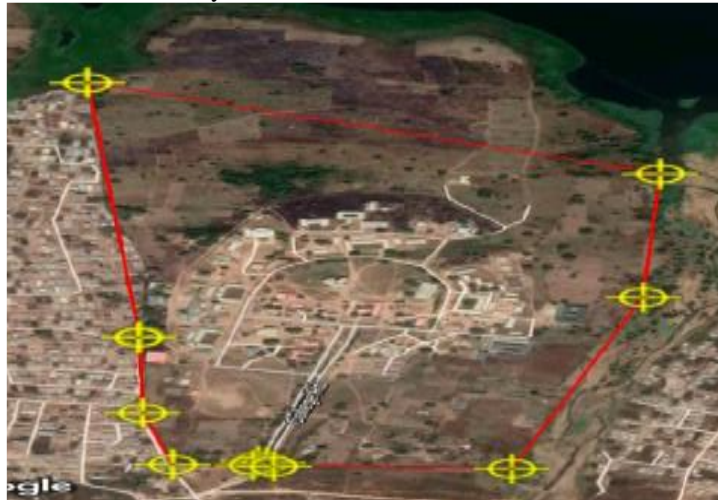
Fig 4: Field reconnaissance of the study area

However, field Reconnaissance survey were done as seen in Figure 4 by visiting and inspection of the site in order to have first-hand information about the study area and to determine various movement about the area in terms of equipment/instrument, personnel required, and ground control network.

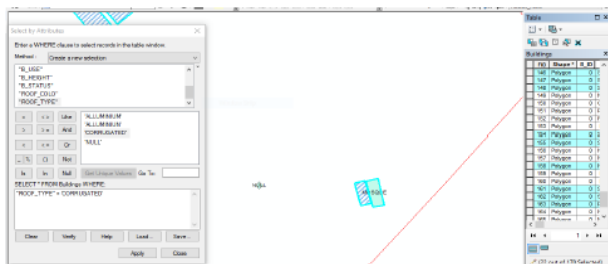
Query: Return All Buildings with Corrugated Roof
 Syntax=Roof Type= Corrugated.

Fig 7: Query showing building roof that is corrugated
 Query: Return Buildings with Aluminum Roof (Type) base on their state of condition (Status) Syntax = “ROOF_TYPE” = ‘Aluminum’ AND “ROOF_STATU” = ‘GOOD’

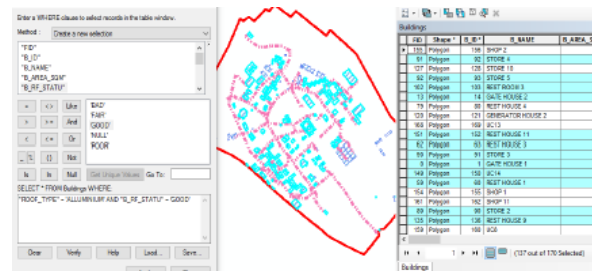
Fig 8: Query Showing building roof type and status Aluminum Roof in Good Condition
 Syntax= “ROOF_TYPE” = ‘Aluminum’ AND “BRF_STATU” = ‘GOOD’

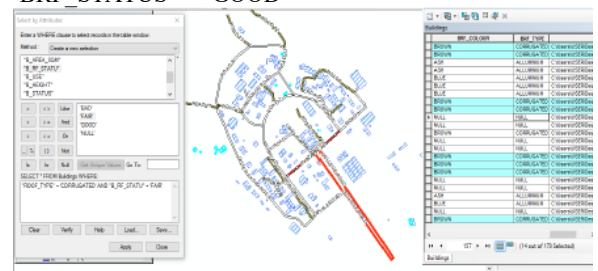
Fig 14: Query Showing Buildings with Corrugated Roofs in Fair Condition
Corrugated Roof in Bad Condition
Syntax=“ROOF_TYPE” = ‘CORRUGATED’ AND “BRF_STATUS” = ‘BAD’

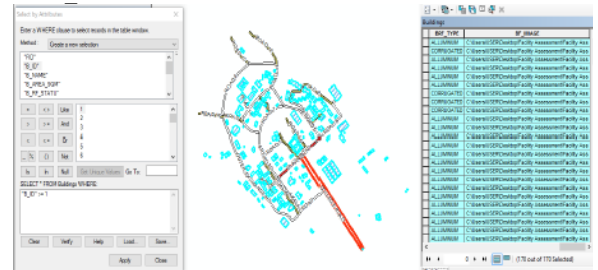
Fig 16: Query showing all Buildings in the Study Area

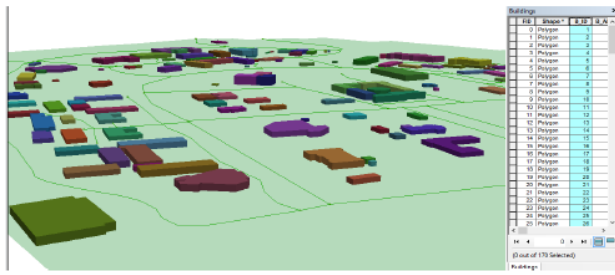
Fig 17: Query showing the 3D view of buildings in the study area Buildings with Aluminum Roof Syntax="ROOF_TYPE" = 'Aluminum'

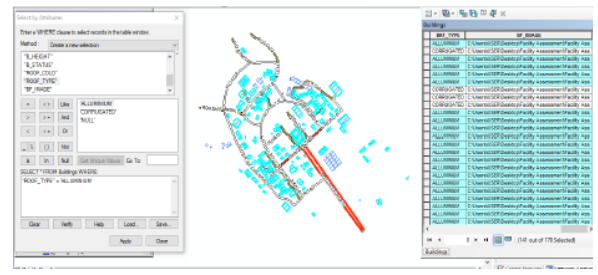
Fig 18: Query showing all Buildings with Aluminum Roof

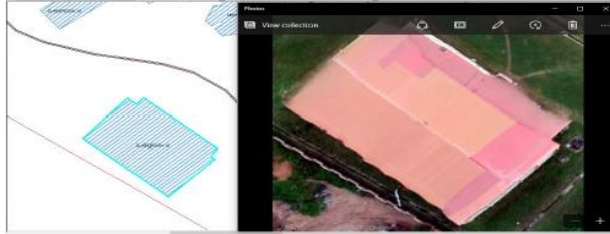
Fig. 19: Query Showing hyperlink of Image of a Building with Aluminum Roof Buildings with Corrugated Roof Syntax="ROOF_TYPE" = 'Corrugated'

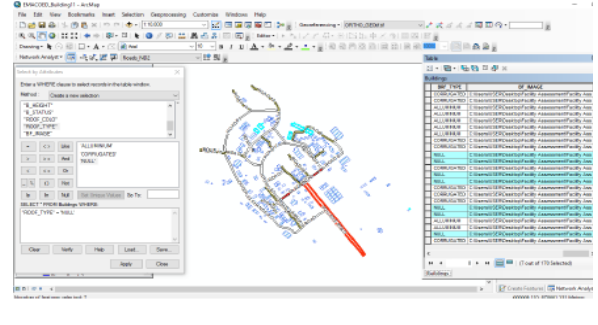
Fig.22: Query showing all the Buildings without Roof

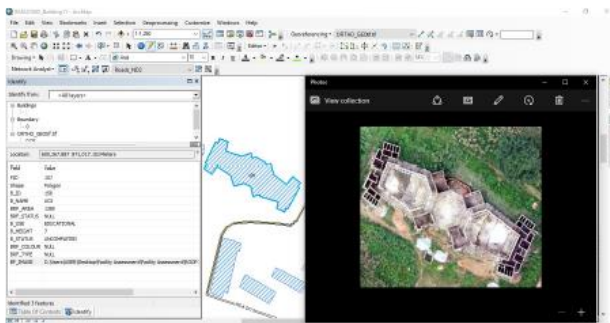
Fig.23: Query Showing hyperlink of Image of a Building without Roof
