# Experimental Investigation of Nonlinear Cyclic Behavior of Circular Concrete Bridge Piers with Pitting Corrosion

**Author keywords:** Bridge pier; Corrosion; Inelastic buckling; Nonlinear behavior; Reinforced concrete; Seismic performance.

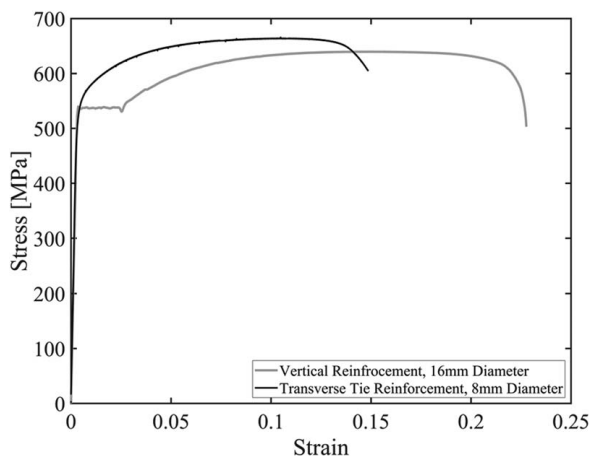
**Fig. 2.** Stress–strain behavior of vertical and horizontal tie reinforcement.

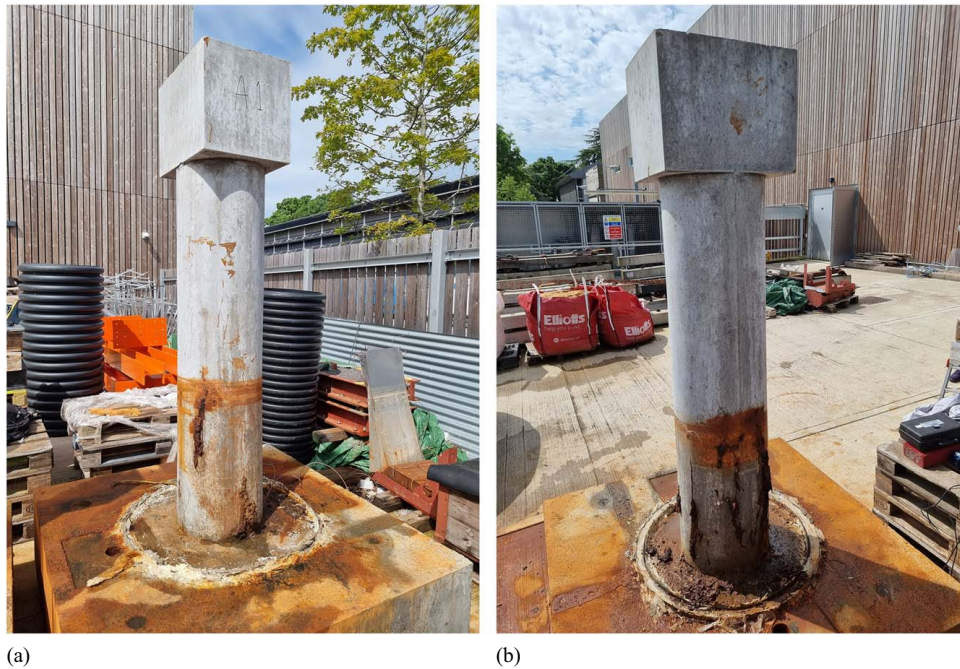
**Fig. 3.** Corroded columns: (a) Column A1; and (b) Column B1.

The accelerated corrosion procedure took 8 and 6 weeks for Columns A1 and B1, respectively. During this period, the average current applied was 5 A. Fig. 3 shows the corroded columns after the accelerated corrosion procedure, where some surface horizontal and vertical cracks were observed. The vertical cracks were due to the corrosion of the longitudinal or vertical reinforcing bars, and the horizontal cracks were due to the corrosion of horizontal hoop or tie reinforcements.

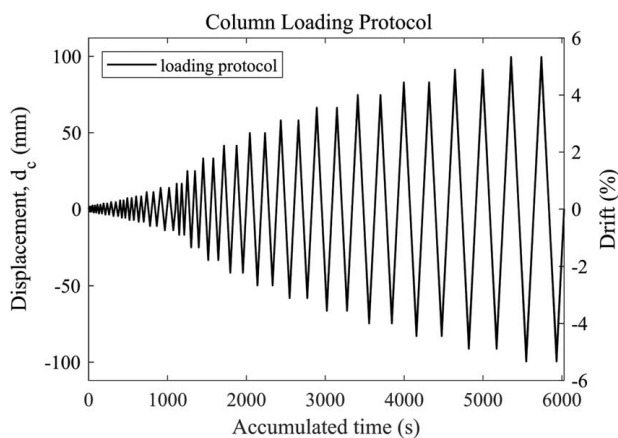
**Fig. 5.** Loading protocol.

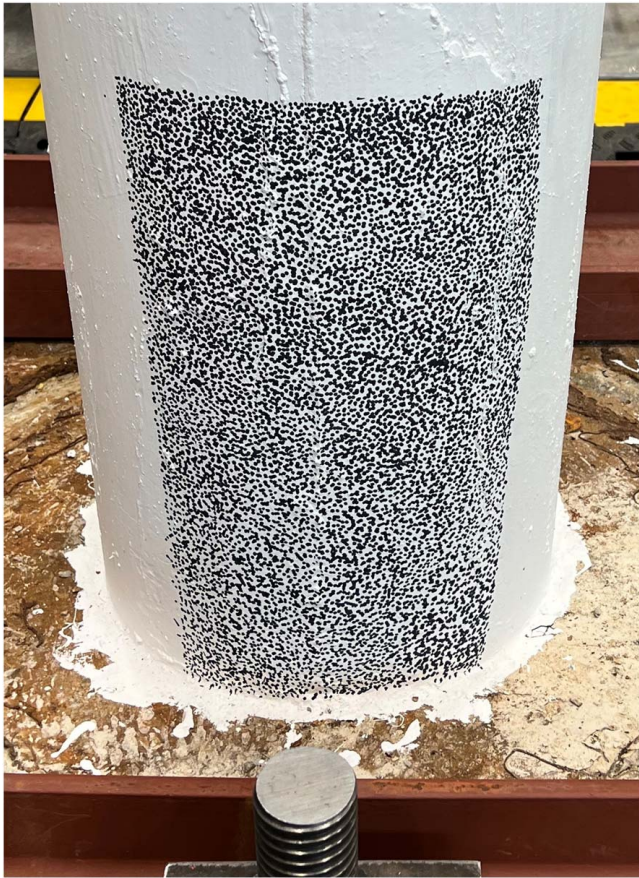
Fig. 6. Speckle pattern for DIC.

interest on the column specimen before deformation occurs, followed by continuously capturing images during deformation (the deformed images). Then, the deformed images are compared with the reference image to compute displacements and strains in the region of interest. A random speckle pattern is applied to the specimen to enable image comparison. These speckles are grouped in DIC into subsets of at least three speckles. The deformation in each subset is used to correlate the displacements and strains in the plastic hinge region of the column. Because the column was circular with a curved surface, stereo DIC with multiple cameras was employed. For these tests, four Manta G504-B cameras, Stadroda, Germany with two Nikon, Tokyo, Japan AF 50 mm f/1.8D lenses and two Nikon 28 mm f/2.8D lenses were used to film at a frame rate of 1 Hz during testing. The DIC images were processed using MatchID Stereo software, Gent, Belgium. Fig. 6 shows an example of a DIC speckle pattern. In addition, the cameras, settings and parameters that were used in the DIC are presented in Table 4.

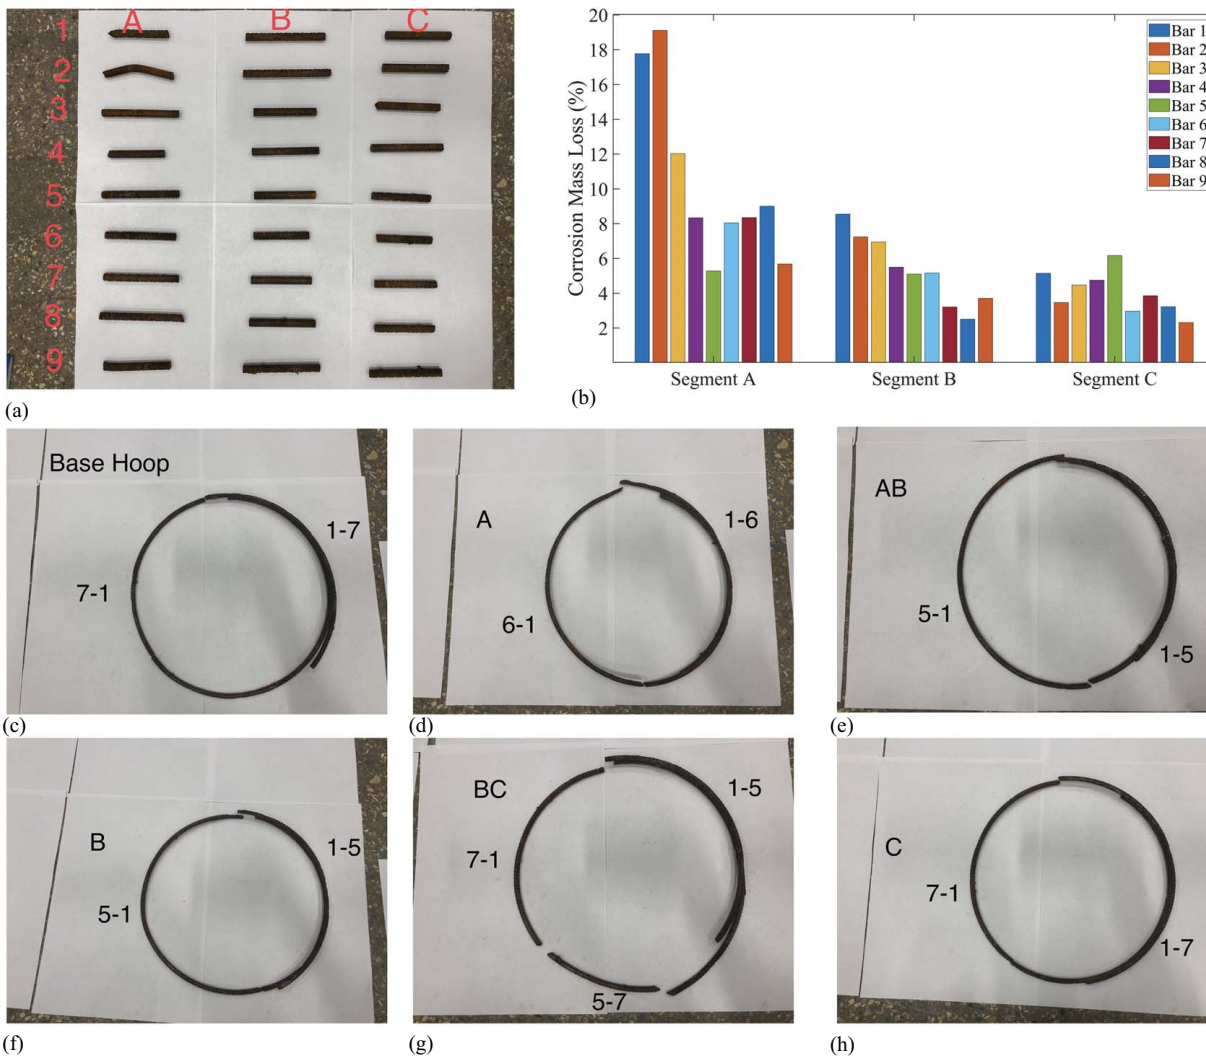
**Fig. 7.** Measured corrosion in Column A1 after cyclic test: (a) vertical bars in each segment; (b) mass loss of individual vertical bars; (c) and (d) hoop reinforcement in Segment A; (e) and (f) hoop reinforcement in Segment B; and (g) and (h) hoop reinforcement in Segment C.

the average corrosion of vertical bars within 200 mm above the foundation was 10.40%. However, the corrosion in Bars A1, A2, and A3 (these references are defined in the attached Excel file with detailed mass loss calculations) was 17.77%, 19.11%, and 12.03%, respectively, which was localized at the base of the column. This resulted in premature fracture in these bars at the base of the column.

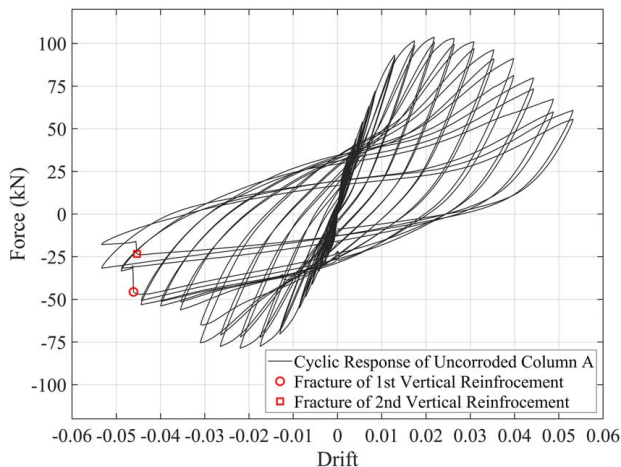
**Fig. 10.** Nonlinear cyclic response of uncorroded Column A.

Fig. 10 shows the nonlinear cyclic response of the uncorroded Column A with the failure points that correspond to the first and second fractures in the vertical reinforcement bars marked. The key damage states are shown in Fig. 11. The flexural cracks due to reinforcement yielding started appearing at approximately 5% drift. At approximately 2% drift, the column base to foundation

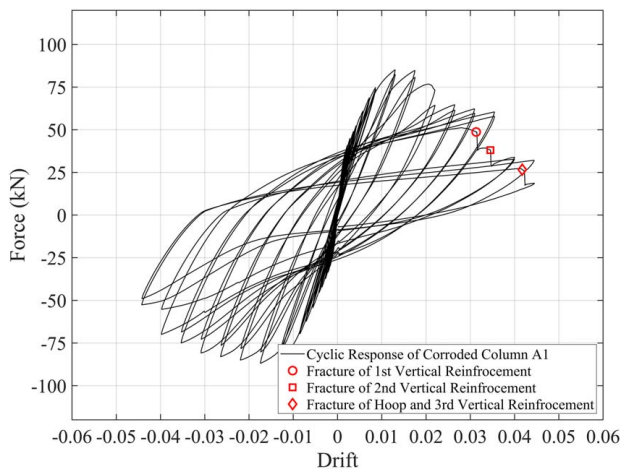
**Fig. 12.** Nonlinear cyclic response of corroded Column A1.

Fig. 12 shows the nonlinear cyclic response of corroded Column A1. The identified failure points are shown in Fig. 12, and the corresponding damage is shown in Fig. 13. The corrosion was localized at the bottom of the column; therefore, the column foundation interface's vertical bar slippage and delamination occurred at approximately 2% drift [Fig. 13(a)] similar to Column A [Fig. 11(a)]. However, in Column A1, Most of the column deformation was concentrated at the base of the column, and therefore, limited flexural cracks were observed during the cyclic tests. As the drift ratio increased, the concrete cover spalled at approximately 3% drift [Fig. 13(b)], followed by a fracture in the first and the second vertical bars at 3.5% drift [Fig. 13(c)]. Finally, the third vertical bar fractured at approximately 4% drift [Fig. 13(d)], which resulted in a complete failure of the column. This failure mode differed completely from the failure mode in the same column without corrosion. This was due to the localized corrosion of a few vertical reinforcement bars at the base of the column. Table 3 indicates that

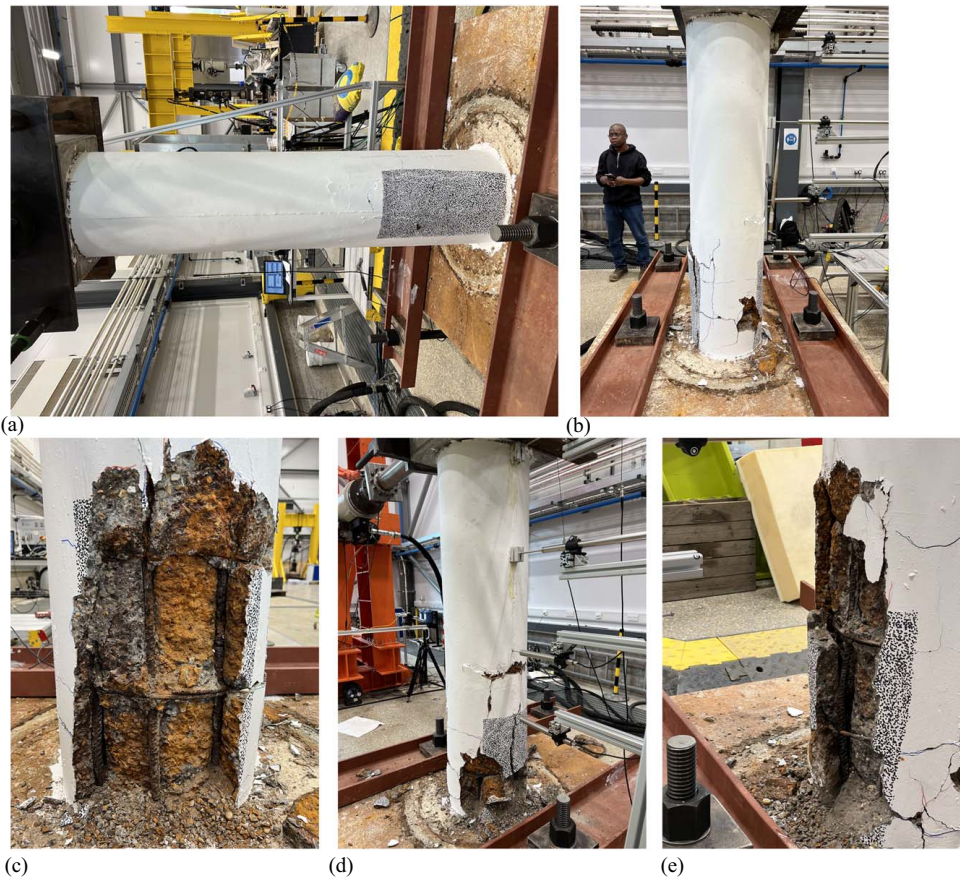
**Fig. 15.** Observed damage during the cyclic test of Column B1: (a) concrete cover crushing/spalling at 0.8% drift; (b) fracture of vertical bar and severe cover spalling at 2% drift; (c) visible buckling at 3% drift; (d) severe core concrete crushing at 3.5% drift; and (e) hoop fracture at 4% drift.

Fig. 14 shows the nonlinear cyclic response of the corroded Column B1. The failure points are shown in Fig. 14, and the corresponding damage is in Fig. 15. The first visible flexural cracks started to appear at approximately 0.5% drift with a vertical crack along a corroded bar. The vertical crack was due to the corrosion crack that existed in the column, and its width increased during the test. At approximately 0.8% drift, premature spalling of the concrete cover on the back face of the column was observed [Fig. 15(a)]. This was approximately 400 mm above the foundation, where the concrete cover was partially spalled due to corrosion before the cyclic test. At approximately 2% drift, the first vertical bar fractured due to severe pitting corrosion followed by

concrete cover spalling [Fig. 15(b)] during the load reversal from tension to compression. Visible bar buckling was observed at 3% drift [Fig. 15(c)], which was followed by core concrete crushing in the following cycle at 3.5% drift. At 4% drift, a corroded hoop fractured, which resulted in core concrete crushing. The significant localized or pitting corrosion 400 mm above the foundation was where the first vertical bar fractured. Here, corrosion resulted in a complete loss of the hoop reinforcement, which resulted in premature concrete cover spalling.

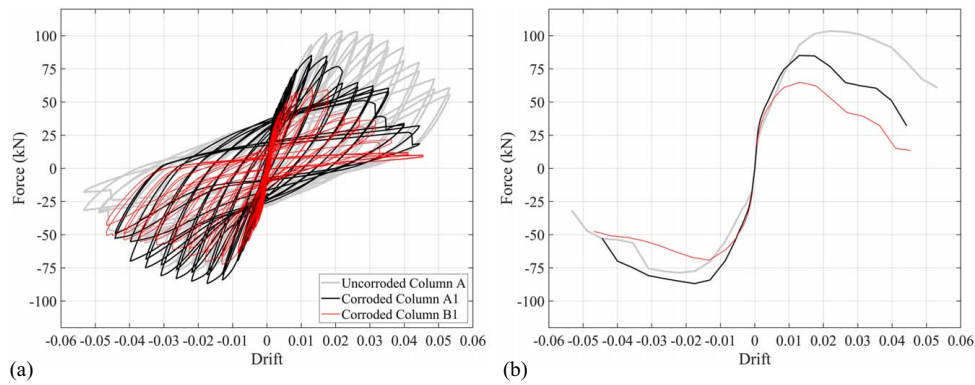
**Fig. 21.** Nonlinear response of all three columns: (a) cyclic response; and (b) backbone curves.
