# Post Bi-annual Maintenance Performance of Geregu Thermal Power Plant

**ABSTRACT** -The continuous firing of a gas turbine engine make it become fouled with airborne contaminants like sand, dust, oil, salt and smoke which encrust the compressor and turbine components. Generally, the deterioration of axial flow compressors is a major cause of loss in gas turbine output and efficiency. The cleaning of the gas turbine compressor is the most effective method of preventing fouling. Cleaning maximises fuel efficiency, the life of the machine and recovers majority of lost power output. The most effective technique of cleaning the compressor and the air-filter of a gas turbine is the offline method. The technique includes injecting water into the compressor when the turbine is turned at cranking speed and requires the turbine to be shut down. This paper presents the performance evaluation of Geregu power plant gas turbine after a bi-annual maintenance operation. The performance parameters such as compressor pressure ratio, compressor discharge temperatures, turbine exit temperatures and power output improved significantly after the bi-annual maintenance operation. The generation utilizat

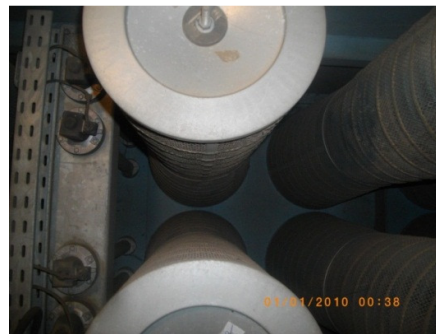
Figure 1. Pulse filters before cleaning

After the various isolations, the intake air system, the pulse filters and the coalescers were all vacuumed. Damaged and worn out filters were replaced with new ones. The cobwebs and dirt were cleaned off from the filter housing. The above process took two (2) weeks.

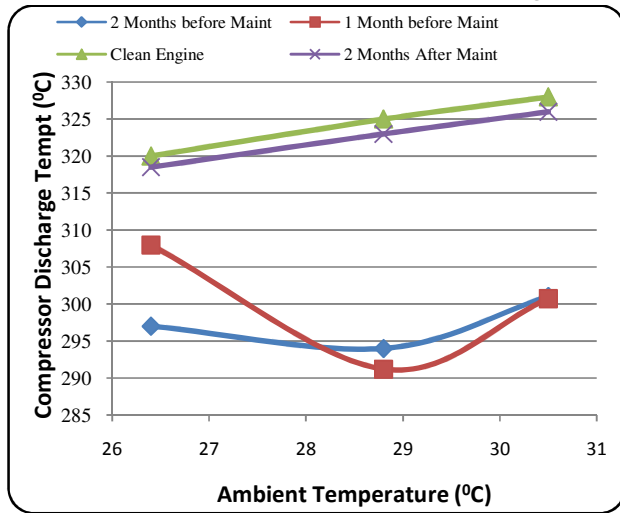
Figure 7. Compressor discharge performance

The compressor discharge temperature (CDT) of the plant was expected to increase with increase in ambient temperature. It was observed that twomonthsand one before the bi-annual operation, the compressor discharge temperature reduces with increase in ambient temperature and attained a deviationof 8.3%and 9% respectively. However, two months after the bi-annual maintenance operation, it was minimised to 0.6% as shown in figure 7.

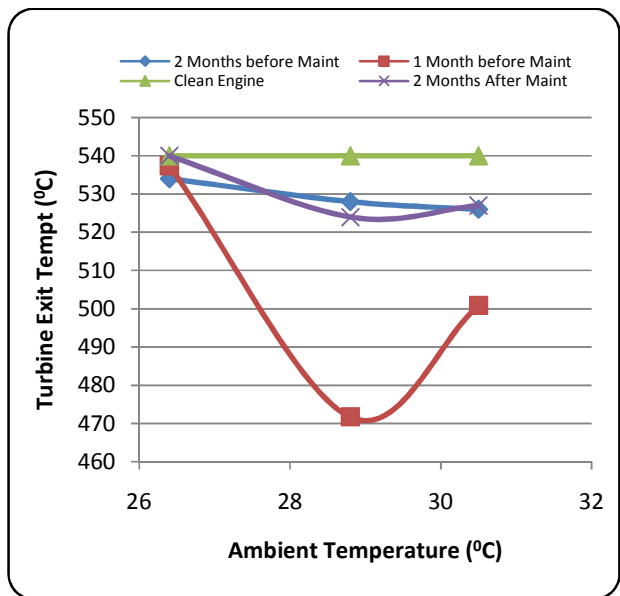
Figure 8. Turbine exit temperature performance

A clean machine should have no change in the turbine discharge temperature (TDT). It was observed that two months and one month before the maintenance, the TDT reduces with increase in ambient temperature and attained a deviations of 3% and 7%respectively. The impact of maintenance was glaring when twomonthsafter the maintenance operations the deviation was less than 2% (figure 8).
