The October 13, 2010 Landslides on The Azenge Mountain in Imande Ukusu, Nkomom District, Kwande Local Government area, Benue State, Nigeria

Ako Thomas Agbor, Abba Francis Mohammed, Onoduku usman Shehu, Nuhu Waziri
Musa, Alabi Adekola A. and Mamodu Adegbe

Department of Geology, School of Natural and Applied Sciences, Federal University of Technology, Minna, Nigeria.

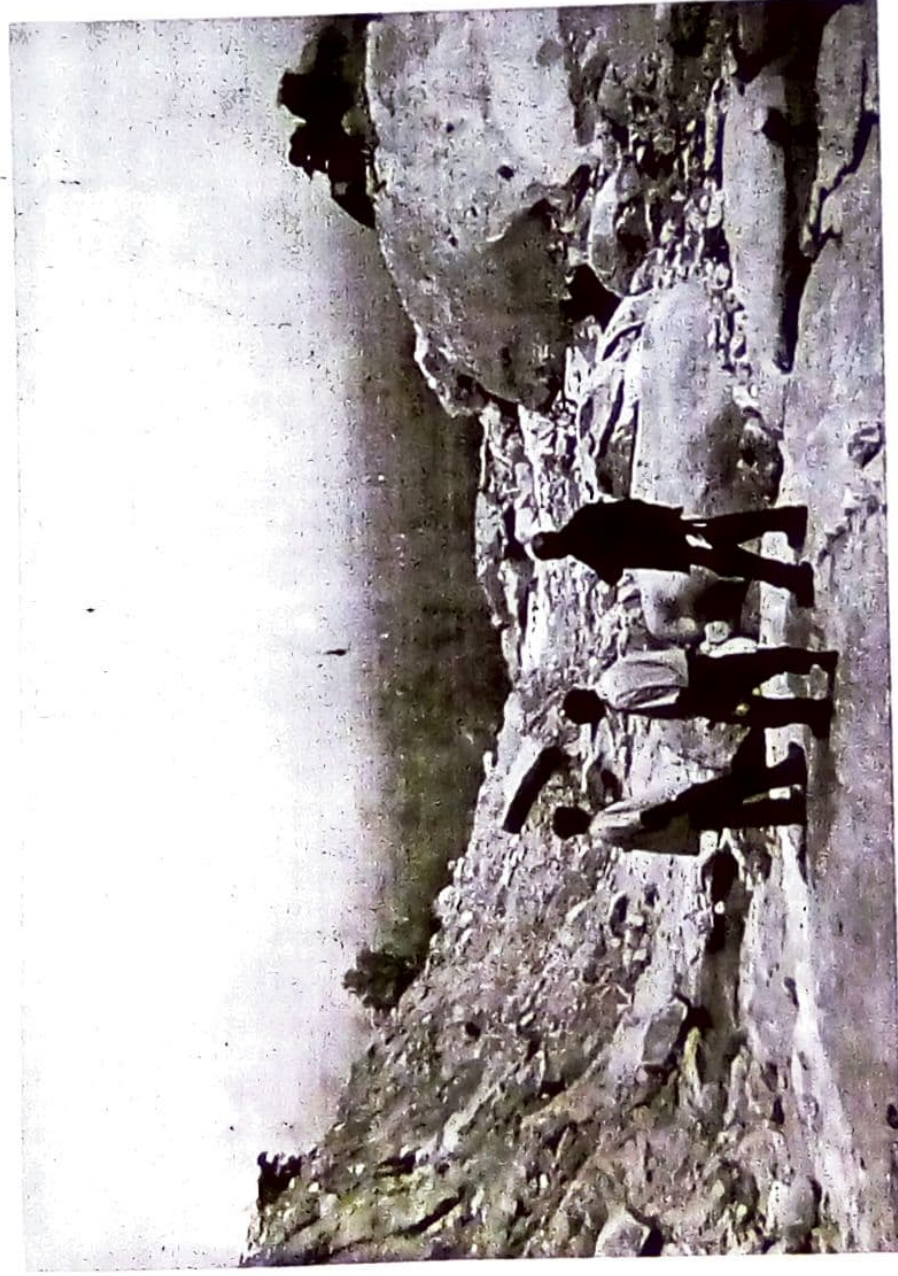
Plate 1: Photograph of major landslide out of the fourteen that occurred in the area

district. A total of fourteen landslides occurred along the huge mountain range surrounding the area but only the one that caused most damage to the area was studied (plate 1). According to him, only one person lost his life. He must have been killed by the remaining large boulders that were sliding towards the toe of the hill on his way to the farm around 5 am. No buildings were affected because human settlements were located away from the area where the landslide occurred.

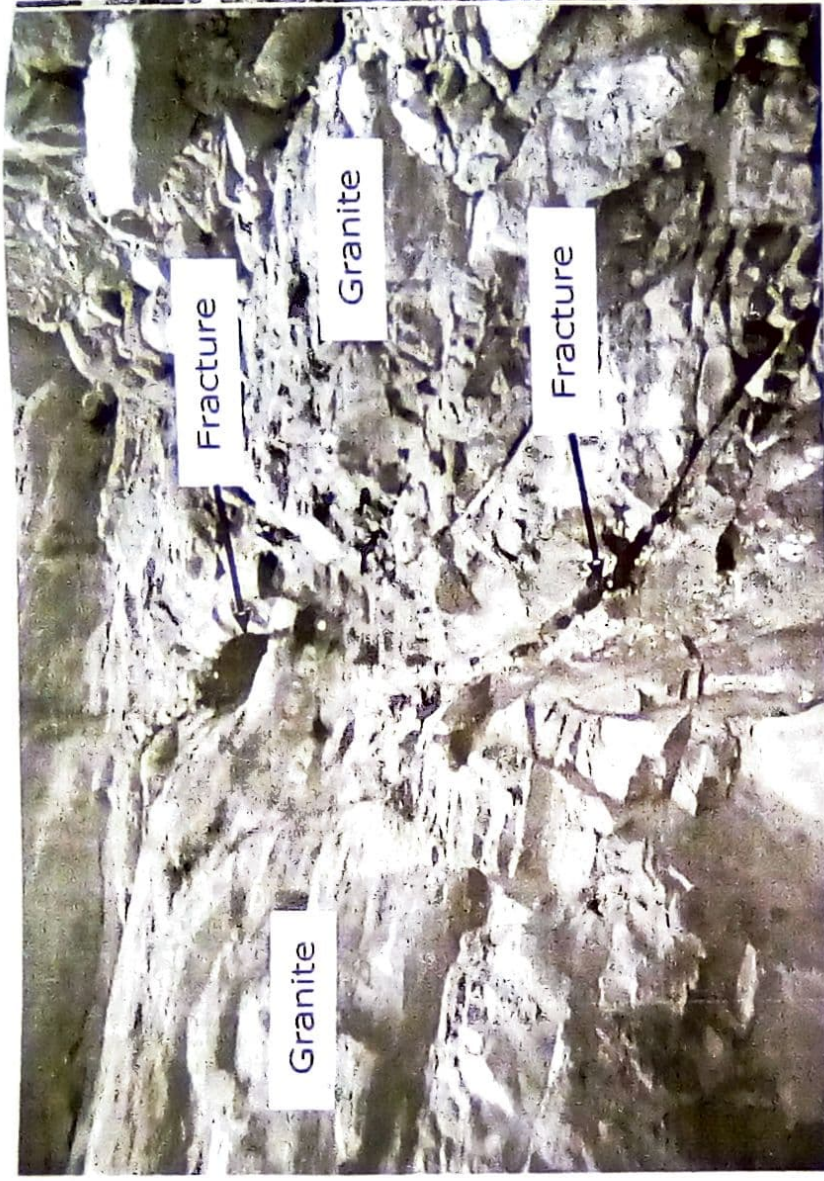
Plate 2: Photograph of fractures that permit water to percolate and cause weathering and weakness of the rock unit

The rock types encountered in the area include gneisses, granites, dolerite dykes and basaltic rocks. Field evidence indicated the existence of granites, gneisses and dolerites lying unconformably on basaltic rocks. The rocks in the study area have a general strike of 240°NW with a dip of 038°NE and were highly fractured. The deep and penetrating fractures in the rocks must have brought about gradual weathering (plate 2). This resulted in slow but steady decrease in the strength of the materials, thus increasing the likelihood of sliding along slopes with gradients of 50° from the top to 5° at the toe (Plate 3).

The presence of too many fractures on both the rocks that were moved and those in the adjoining area suggests fractures in the rock provided passage for weathering fluids (Plate 2). Fractures in the rocks acts as common translational slip planes. The presence of some clay minerals along some fracture zones in the rocks supports the view that the landslides occurred as a result of absorption of water by these clay minerals (Ayonghe et al., 2004 and Plummer, 2003).

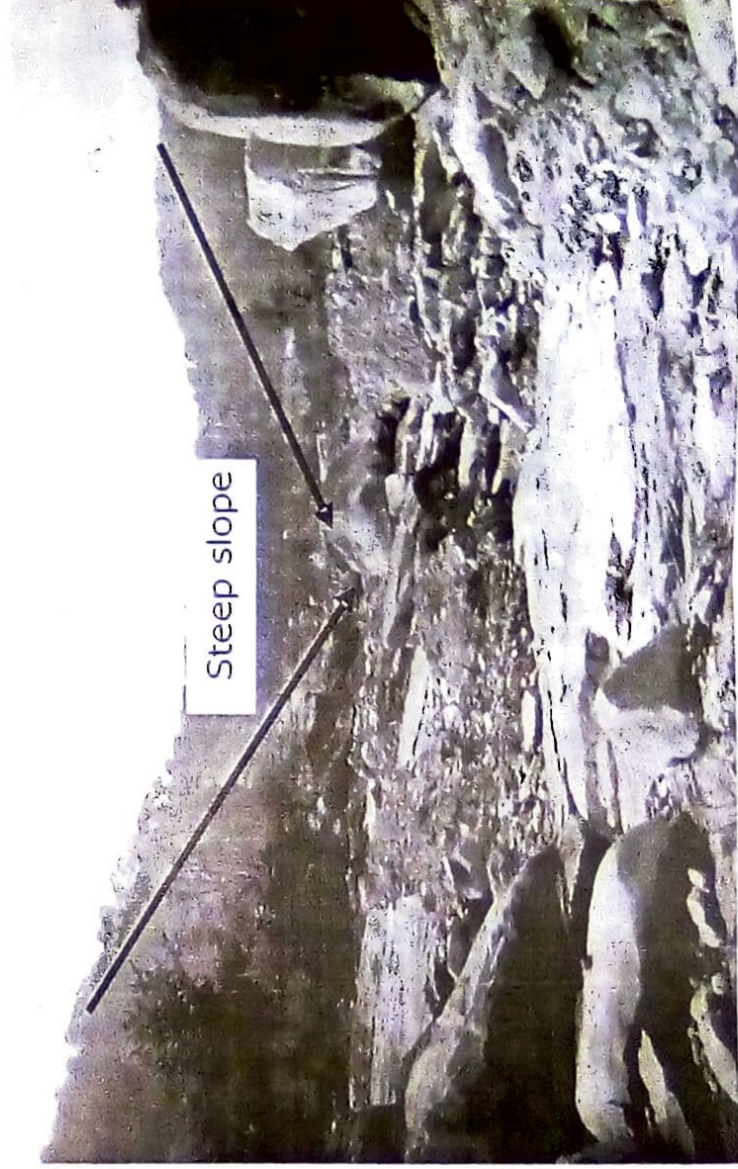
Plate 3: Photograph of steep slopes the facilitated the movement of material down slope

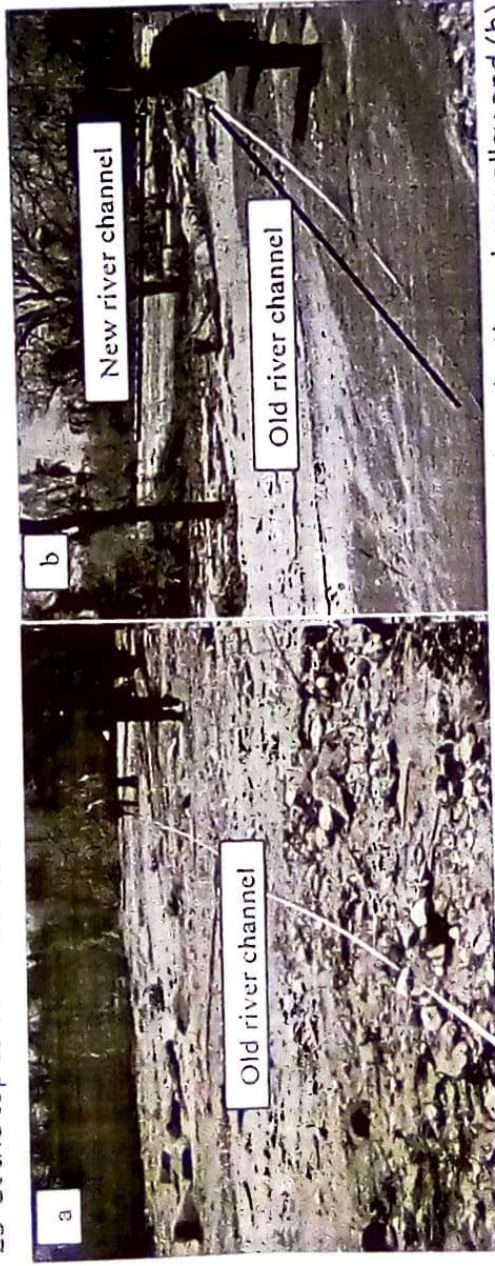
Plate 4: Photographs showing (a) materials deposited on the then river valley and (b) the development of a new river valley tangential to the old one

The materials from the slide were made up of fine debris to large fragments of the granitic and gneissic basement complex which has been intruded by dark coloured rocks believed to be volcanic rocks. The materials were deposited along the sliding path and the size of the materials decreases from the top to the bottom of the hill. The materials that were moved to the foot of the hill were deposited in the bed and flood plain of the then existing river with a width of 38.5m (plate 4a). The deposition of the materials resulted in the diversion of the river course and development of a new river tangential to the old one (plates 4b). Materials deposited were mainly small rock fragments, sand, mud and dead plant materials. The saturated soils following heavy rainfall acted as a lubricant for the materials to move rapidly and in mass down slope. The Azenge Mountain where the sliding took place has an elevation of between 950-2100m above sea level and lies along the Nigeria-Cameroon boarder with slope angles ranging from 25° at the top to 60° at the foot or toe.

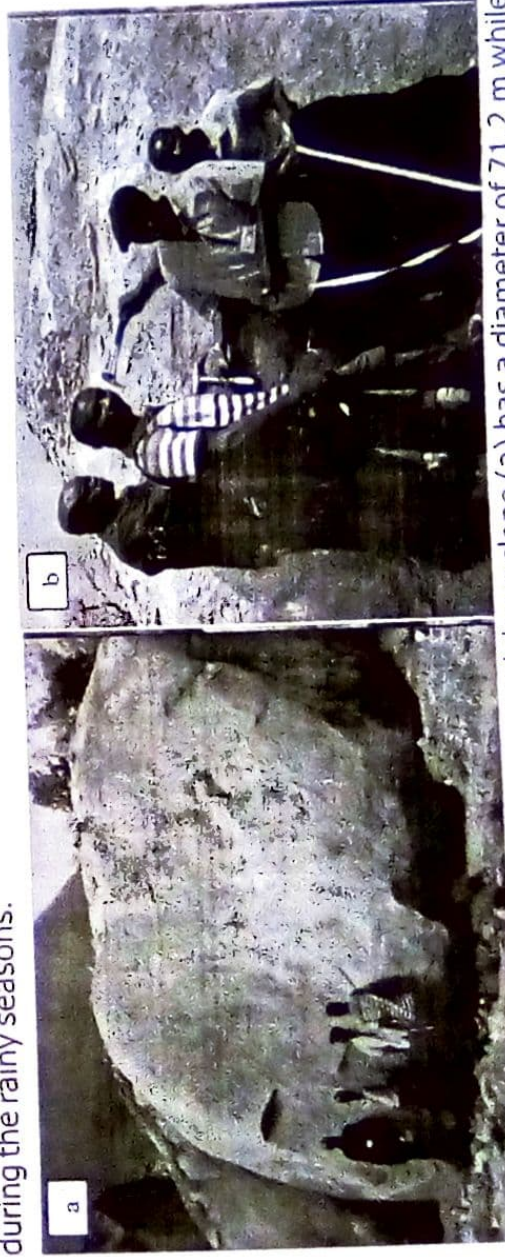
Plate 5: Photographs of boulders moved down slope (a) has a diameter of 71.2 m while (b) has a diameter of 88.5m. Size of materials moved decreases down the slope.

The landslide scar increased in width from the top (20m) to the base (75m) with an average depth of 58.73m and a total length of 950m. The largest boulders moved measured 15m long, 10.6m wide and 52.5m high (Plate 5a and b). The sites of the 14 slides correspond to old fault planes which have acted as conduits for the flow of water during the rainy seasons.

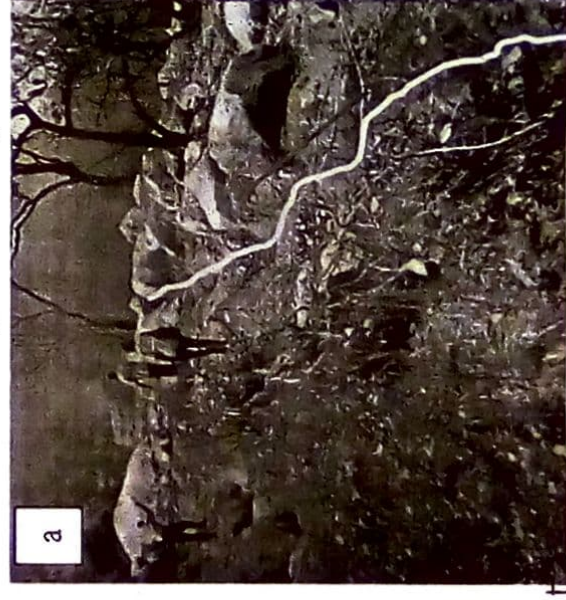
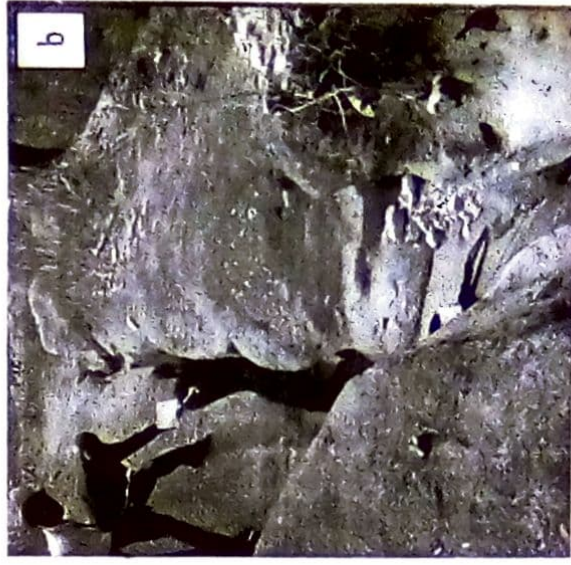
Plate 6: Photograph of gullies produced (a) at the top and (b) at the foot of the hill. Note that the depth and width of the gullies increase from the top to the foot of the hill

Human activities like farming and lumbering have been taking place within the area where the sliding occurred. The erosive action of the river and flood waters at the toe or foot of the hill was very visible as small and steep gullies appeared within the area where the landslide occur (plate 6a and b).

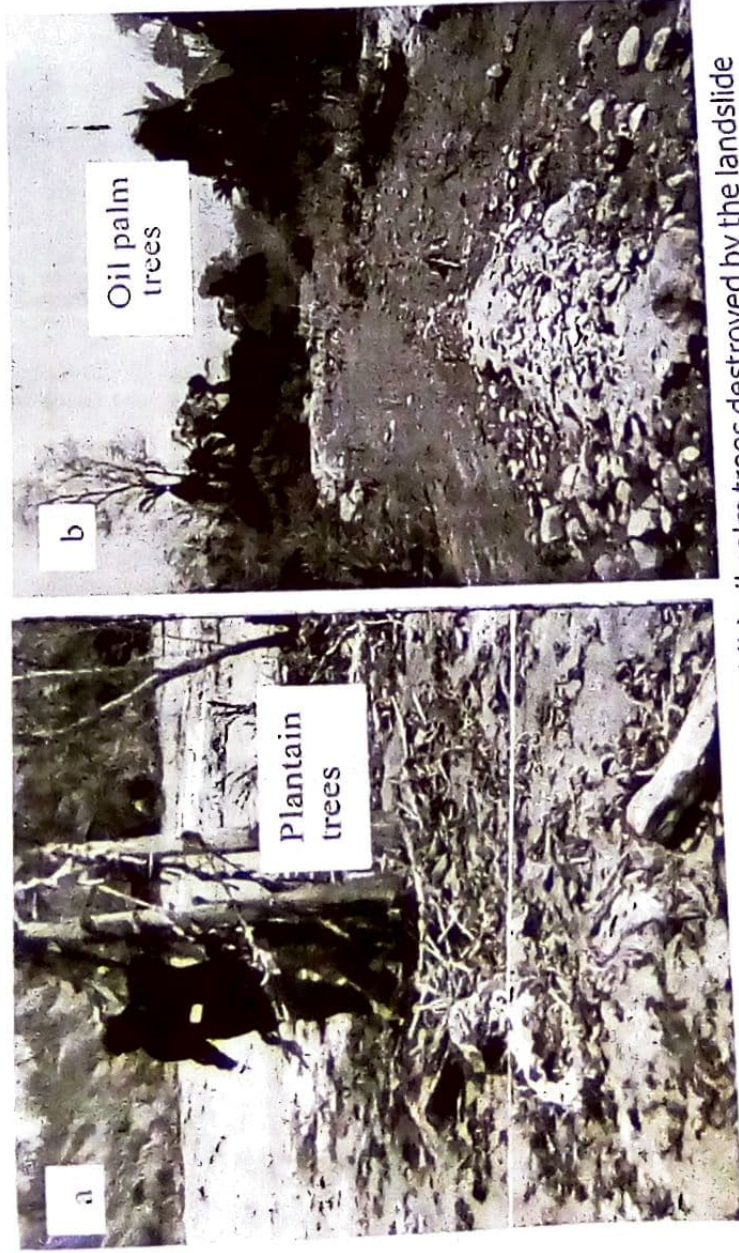
Plate 7: Photograph of (a) plantain and (b) oil palm trees destroyed by the landslide

Field investigation equally showed that three rice farms, plantain farms and oil palm farms of about 200 square km and a large number of palm trees and other economic trees were destroyed (plate 7a and b).

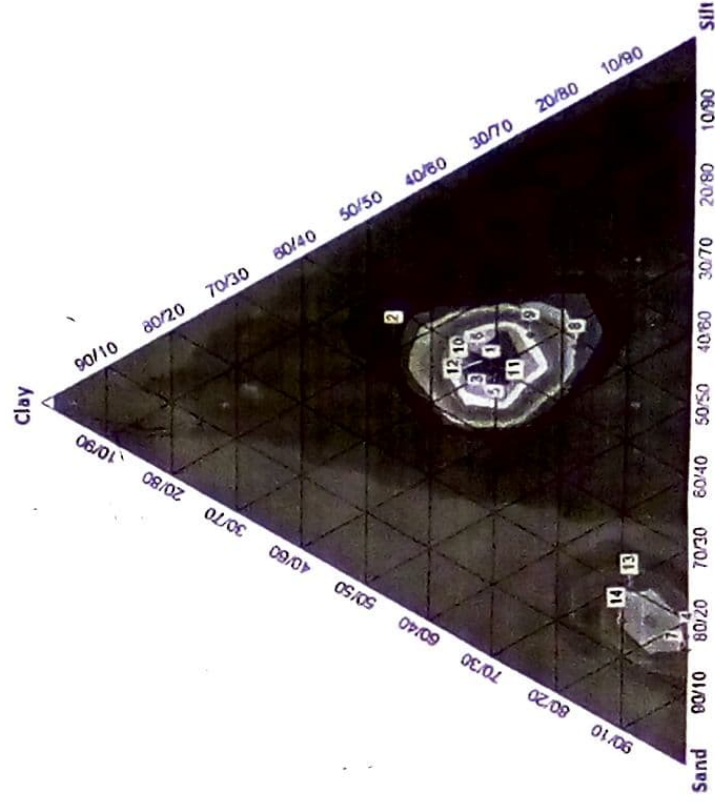
Figure 3: Plots of results of grain size analysis showing two groups of soils based on their susceptibility to sliding (modified from Ayonghe and Ntasin, 2008).

The results of sieve analysis of the fourteen soil samples collected from the landslides site is presented in table 1 and plotted figures 3. These show that the soil display a wide range of grain sizes including clay, silt and sand fractions. However, most of the samples (1,2,3,5,6,7,8,9,10,11, and 12) are composed of mainly clay sized particles (Tsable 1). They are interpreted as soils of grain sizes that are mostly susceptible to sliding. These soils combined with water act as lubricant. A plot of these samples on the grain size triangle (Fig.3) reflects soil with very high degree of susceptibility to sliding above the sliding surface. However, four samples (i.e. 4, 7, 13, and 14) that were collected below the sliding and away from the sliding surfaces are mostly made up of sand and are less susceptible from sliding and plot outside the failure zone. These samples tend to be predominant of one grain size fraction that tends to cause instability within the unit (Fig. 3).
