Architect's and Geologist's View on the Causes of Building Failures in Nigeria

Amadi A. N.¹, Eze C. J.², Igwe C. O.³, Okunlola I. A.¹ & Okoye N. O.¹

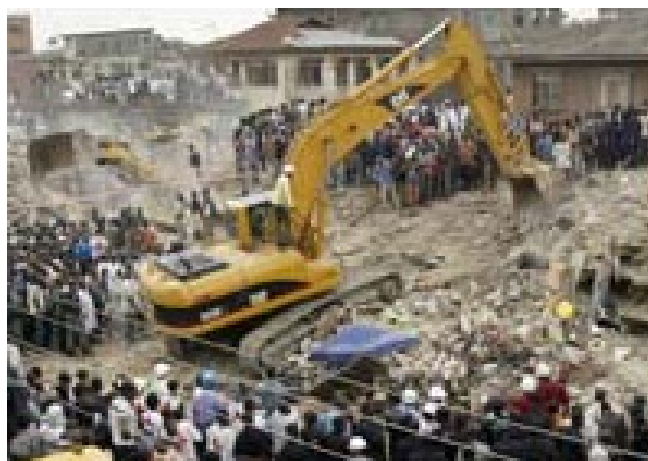
All engineering works start with the foundation. The purpose of a foundation is to transfer the load of structure to the ground without causing the ground to respond to uneven or excessive movement. Such load must be transferred in such a way that there will be no shear failure in the underlying soils. Many buildings have collapsed due to faulty foundation (Figure 2). Most of the foundations in Nigeria are designed without considering the soil type on which they rest upon. Therefore, it is vital that adequate soil investigation should be carried out before designing of foundation in-order to have a suitable design to suit the local geology of the area.

Figure 2. Collapsed building arising from foundation failure (Source: Author, 2012)

- (a) A pre-constructional geotechnical survey or soil survey should be carried out before the commencement of any design and or construction especially in low lying terrain susceptible to high ground water table fluctuation and compressible soil.

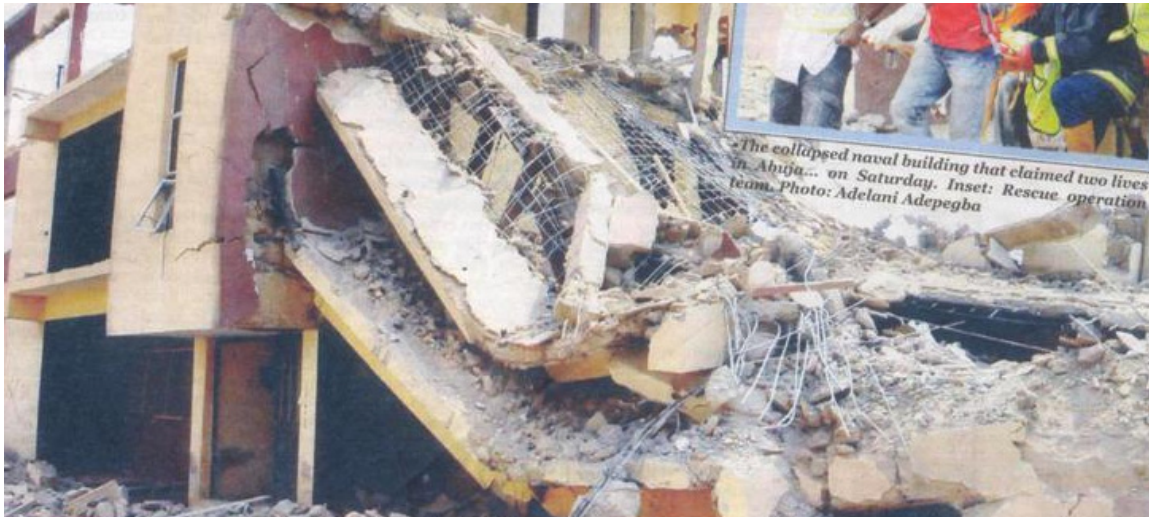
A number of professionals (stakeholders) exist in the building industry, but in most cases their services are not sought for due to one reason or the other, such professionals include: Architects, Quantity Surveyors, Land Surveyors, Builders/Contractors, Engineers (Structural, Civil, Mechanical, Electrical, and Geotechnical). It has been observed that due to high cost of consultancy fees needed to engage the services of these professionals, most Nigerians prefer to cut cost by engaging the services of non professionals (quacks) who lack the needed experience in construction sector. This is reflected in poor workmanship and low standard of construction, which results in structural failure and collapse of part or the entire building. Take for instance, the recent loss of human lives in the collapse of two storey building located at road 45, 1st Avenue Gwarinpa, Abuja on the 28th of January, 2012; according to 'Sunday Sun Newspaper' of January 29, 2012 on page 11; the collapse was as a result of involving non-professionals in the demolition of the said building for further renovation which led to collapse of the structure (Figure 3).

Figure 3: Building collapse as result of engagement of quacks/non-professionals (Source: Sunday Sun Newspaper' of January 29, 2012)

- (b) Engagement of Professionals from design stage to completion stage should be made mandatory in the construction of future building.
- (c) Various regulatory bodies such as Council of Registered Engineers (COREN), Council of Nigerian Mining Engineers and Geoscientist (COMEG), Architects Registration Council of Nigeria ARCON and Council of Registered Builders of Nigeria (CORBON), should ensure that only registered and qualified professionals are involved in the construction of future buildings in order to minimize failures.
