**IIARD International Journal of
Geography and Environmental Management**

Impact of Gully Erosion on Landuse /Land Cover in Bida Town Niger State, Nigeria

Mahmud, Habiba Lami & E.T. Umaru
Department of Urban and Regional Planning
Federal University of Technology
Minna, Nigeria

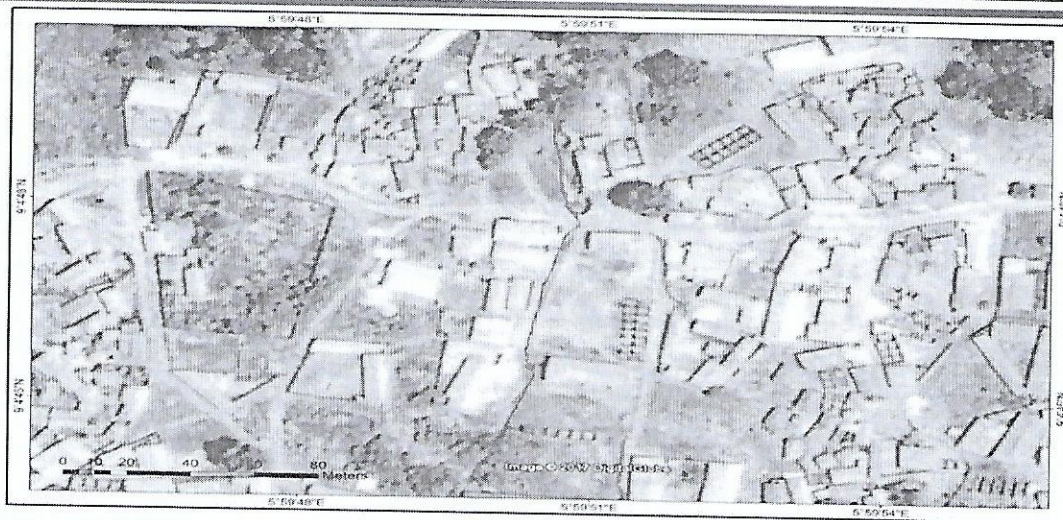
Figure 1: Satellite Image Showing the Gully in 2005 at Site 1 (Dakodza Area)

The satellite imagery was processed to determine the temporal changes of gully erosion in study area site 1 between 2005 and 2015 and then 2015 and 2016 for the site 2. Figure 2, 3, and figure 4 reveals the significant changes in gully morphological variable at site 1 (Dakodza). The width of gully has been expanding over time, figure 2 shows that a total land area of 123.6m² (6.6%) was claimed by gully in 2005, figure 3, showed that in 2010 gully expanded and covered a total area of 476.1m² (25.2%) and figure 4, revealed that this disaster occupied a total land area of 1285.2m² (68.2%) in 2015. At site 2, figure 5, reveals that gully eroded a total land area of 391.2m² (13.3%) in 2015 and figure 6 shows that gully covered a land area of 2549.m² (86.7%) in 2016.

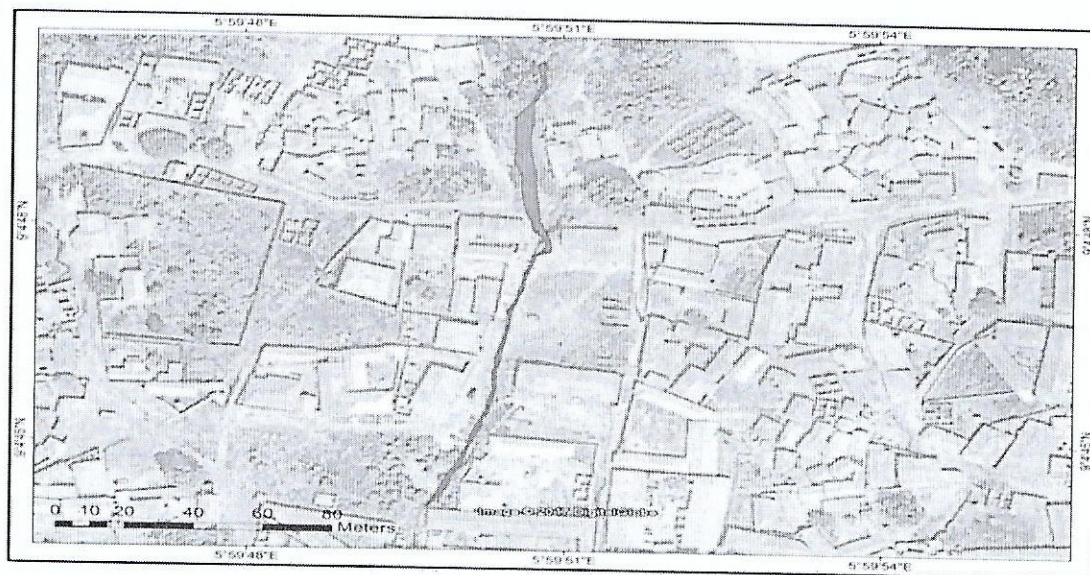
Figure 2: Satellite Image Showing the Gully in 2010 at Site 1 (Dakodza Area)

Gully length also witnessed changes from 182.6m² to 219.5m² and from 322.05m² to 444.85m² at both site 1 and 2 respectively. The interpretation of the satellite image shows an increase from 182.6m² (30.2%) in 2005 to total areas of 202.3m² (33.5%) in 2010 and 219.5m² (36.3%) in 2015 for the site 1 and for the site 2 gully increases from 322.1m² (42.0%) in 2015 to total areas of 444.8m² (57.0%) in 2016. This indicates that gully erosion is developing at an alarming rate especially at the study site 2. If the erosion menace is not urgently addressed, buildings and other vital infrastructure as well as vegetation that protect the top soils within the vulnerable areas will be devastated within few years.
