QUALITY OF ROAD TRANSPORT INFRASTRUCTURE IN MINNA METROPOLIS, NIGERIA

Oluwole, M.S.^{1*}, Ojekunle, J.A.¹, Masugari, D.Y.², Usman, A.K.³, Dalil, M.⁴
and Abdullahi, M.I.¹

¹Department of Transport Management Technology, Federal University of Technology, Minna.

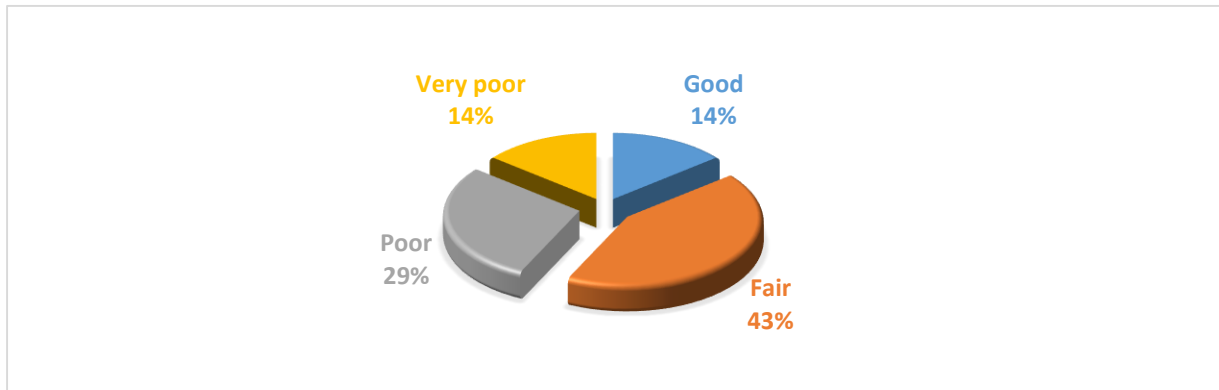
Fig. 2 Arterial Road Surfacing Condition

The total length of the arterial roads is about 80.66 km. The surface condition is observed to be good along Maitumbi Junction, fair along Eastern by-pass and Gwada junction and very poor along Bida road. The Bida road rated to be very poor has numerous large, deep potholes and alligator cracks. The basis of this classification is on the number and size of potholes and cracks noticed along the roads, Paiko road surfacing is poor because it has lots of small sized potholes and cracks, while Eastern bypass and Gwada road had few small-sized potholes and alligator cracks. The Maitumbi road is free from potholes and cracks as at the time of the study hence the good ratings. The length of each of arterial road as a proportion of the whole was computed in order to determine the percentage of the arterial road with good surfacing and the outcome is presented as Figure 2. Deriving from this, 72% of the arterial road network in Minna metropolis

has no good surfacing, while only 28% have good surfacing. Plate I shows some alligator cracks along Bosso Road- Minna.
